AMERICAN AIRLINES SYSTEM

December 18, 1947

DC-6 FIRES

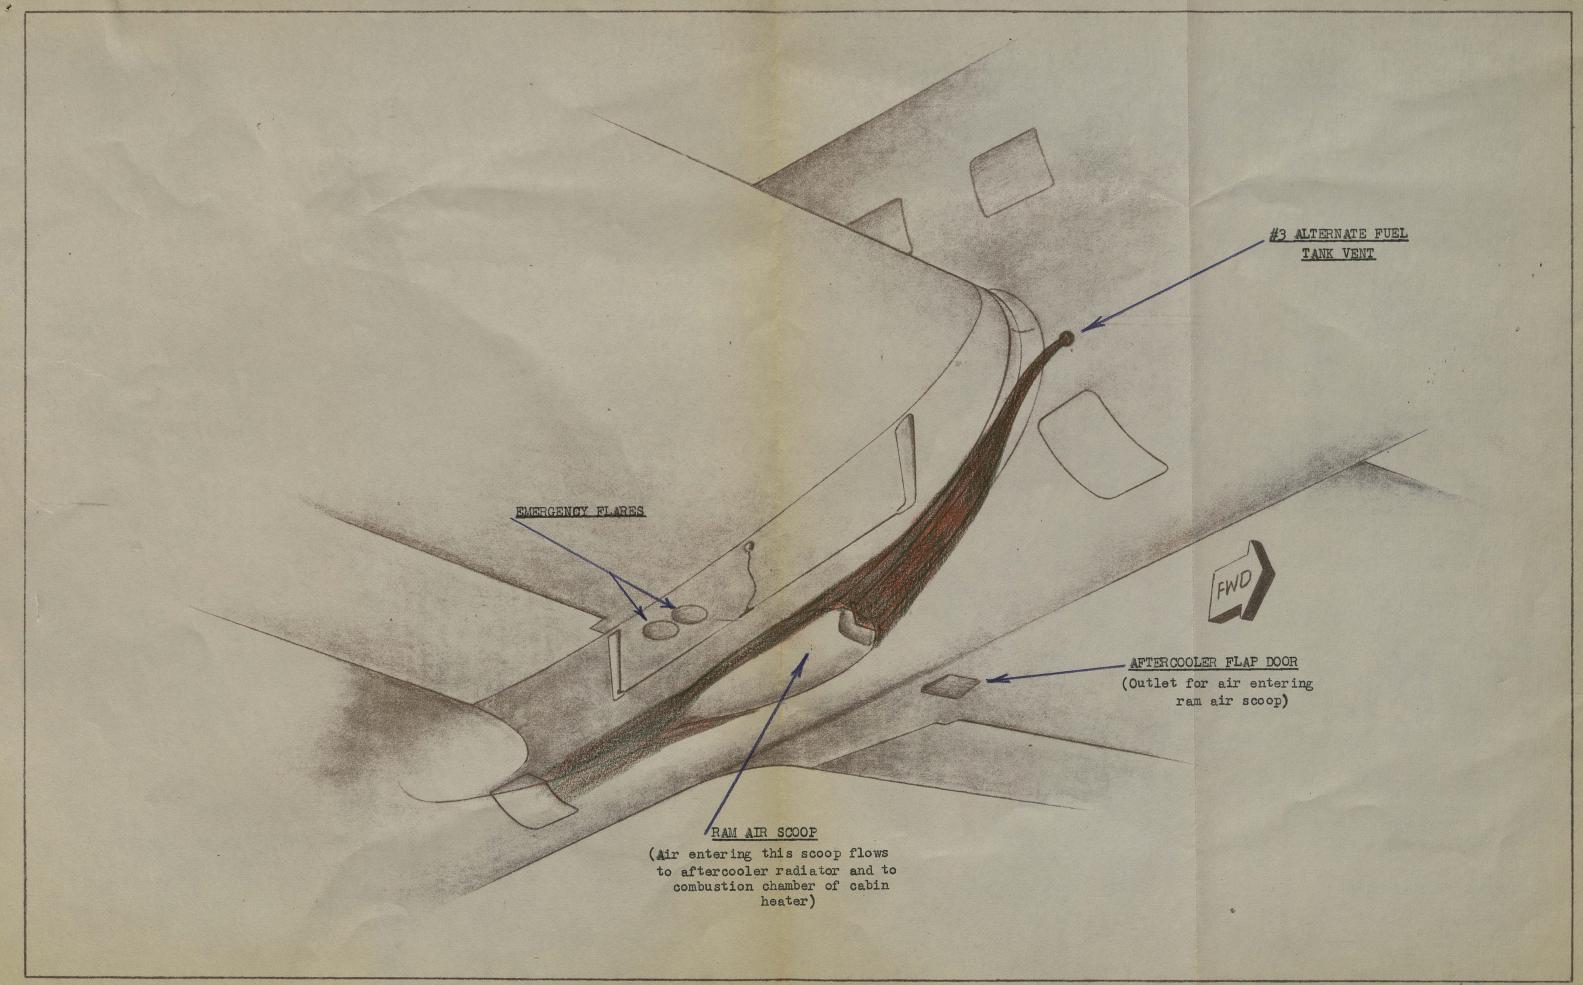
Figure 10 - Fuel System Diagram

Figure 2 shows the fuel system of the airplane which involves a number of tanks located throughout the wings. There are four main tanks (one per engine) and four alternate tanks. These tanks are interconnected by valves and pipes so that fuel from any tank can serve any engine. There are in the system several booster pumps which serve to supply a full flow of fuel as required. These booster pumps may also serve as transfer pumps and have been commonly used to move fuel from one tank to another to compensate for variable usages or quantities. Each fuel tank is, of necessity, fitted with a vent outlet to allow the passage of air as tanks are filled or emptied. These vents have been located on the airplane as indicated in Figure 2, the locations being influenced to some extent by the necessary external pressure conditions to secure proper fuel tank operation. The fuel vent outlet for number three alternate fuel tank was located on the right lower side of the fuselage, almost immediately at the junction with the airplane wing.

Two obvious corrections are required to insure against a repetition of such an incident. First, the alternate tank vent must be relocated to a safe place. This is being accomplished and along with it, all other tank vents will eventually be relocated in the outboard wings. The second obvious change is the relocation of the ram airscoop insofar as it serves as an intake to the combustion heater. This intake will be placed in the leading edge of the wing forward of any possible flow of fuel. The intensive investigation naturally disclosed a number of other items to be improved, some of which were considered mandatory before flight -- most of which, however, are listed as ultimately desirable. Such changes include the increase of fire detecting devices and fire extinguishing capacities, and installation of access windows to the underfloor compartments. Another change involves the reworking of all heater accessory units to provide additional safety features and the provision of supplementary emergency shut-off devices in the possible event of heater mal-functioning, Numerous detailed improvements will eventually be made in electrical installations and equipment. The application of numerous drains and dams to restrain possible inflammable fluid leakages will also be accomplished. The eventual program will also involve the widened application of stainless steel and fire resistant materials in numerous areas and the development of an improved supercharger and its oil cooling installation. There are, of course, innumerable minor improvements which have crept into the program but the time required for earliest possible return to service is established by the first item listed above; namely, the relocation of vents and cabin heater air intake, and improved fire detection and protection in the under-floor compartments. The program is being worked on with the greatest intensity and all the agencies involved have been extremely cooperative in helping to resolve and expedite the program. Pending the possible development of satisfactory protection devices, fuel transfer has been prohibited for both DC-4 and DC-6 airplanes.
