Comparison of the
Convair 340 and 240

Airworthiness
Review

Comparison of Convair 340 and 240

By L. Homer Mouden

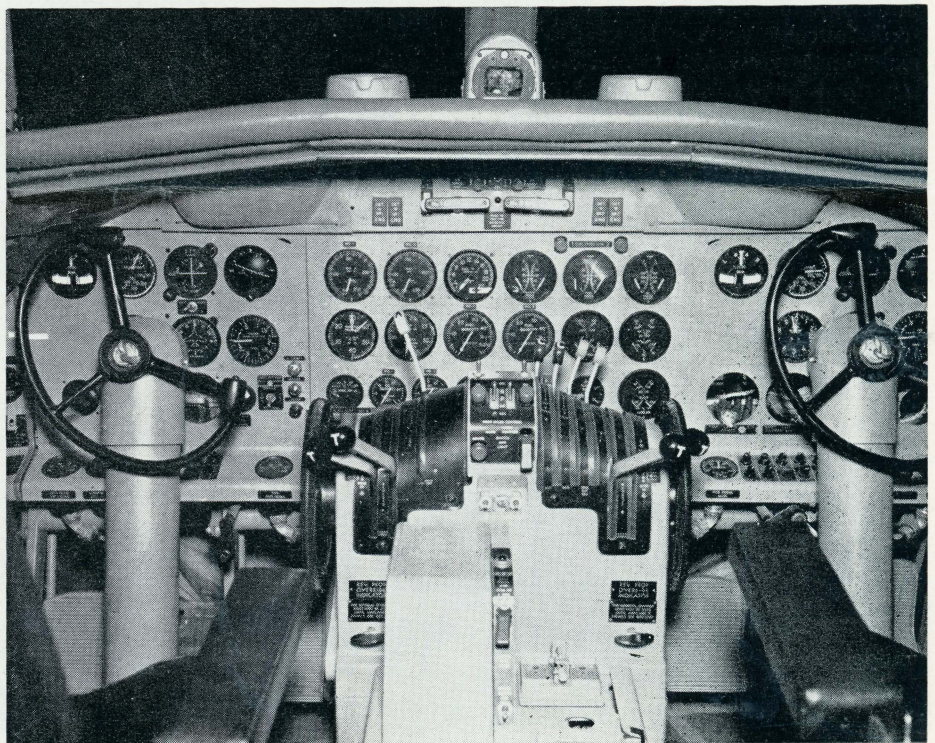
Instrument panel and engine control unit.

Controls on the throttle pedestal are convenient and easily accessible. It would have been an improvement, however, if the controls on the throttle pedestal had been rearranged so that the mixture controls were separated from the carburetor heat controls to prevent accidental pulling of the mixture when reaching for the carburetor heat, as has been known to occur on the 240s. This could have been accomplished by installing the mixture controls on the left side of the pedestal inboard of the pilot's throttles, where there is now a vacant space not utilized by the new auto-pilots.

The instrumentation, as observed on the UAL model, seemed convenient and satisfactory with the exception of the flap indicator. I am of the opinion that flap management is too important a feature in the proper handling of the 340, or any other modern airplane, to have the flap position indicated by so small an instrument located in the lower center instrument panel, where it cannot be quickly and easily read by the pilots. I believe that a flap indicator of standard instrument size of 3 1/4" diameter with 1° flap markings, as used in the 240, is a necessary installation. The flap indicator should be located in a position as near as possible to the upper righthand corner of the center instrument panel, so that it can be easily and accurately read by the copilot, and is also easily seen by the pilot.

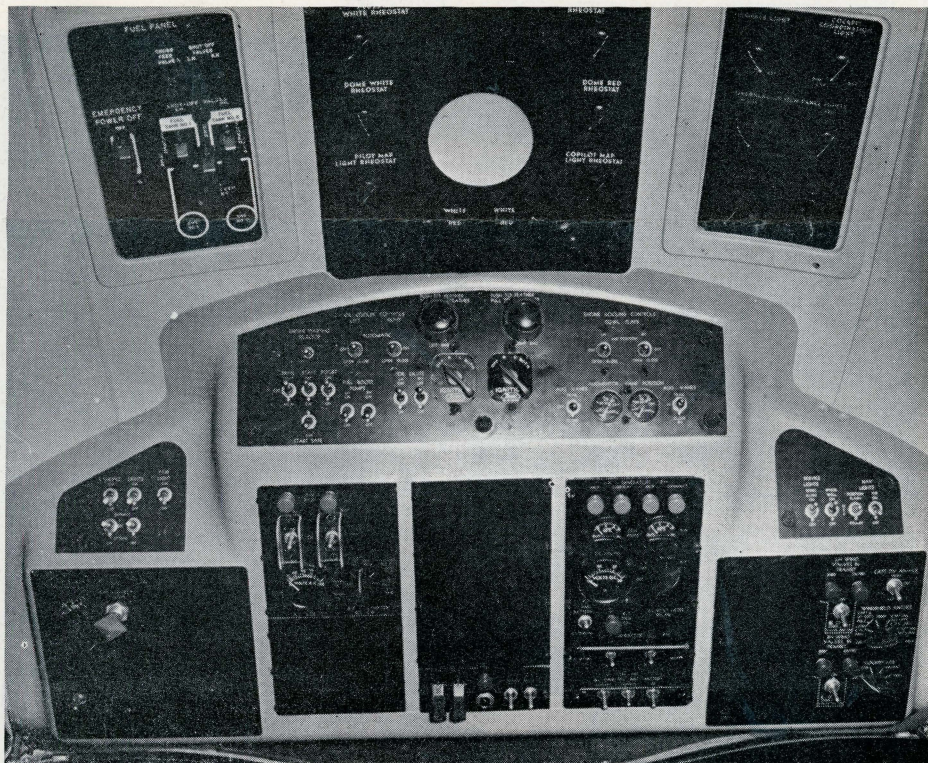
The installation of additional electric equipment has brought the location of the feathering buttons overhead a little farther aft in relation to the pilot's position. This has placed them in an even less desirable location than in the 240s. In the pilots' opinions, the logical location for the feathering buttons is on the fire-control panel located immediately above the center instrument panel, and just under the glare shield. There they would be conveniently available without danger of being tripped accidentally. The pilots are bringing this item to the attention of their respective companies, with

good prospects of effecting a change to the proposed location. This would make the "lights out" check of the buttons on takeoff much easier, and would permit the co-pilot to keep his vision forward instead of looking toward the top of the cockpit at the start of the takeoff roll. They would be under observation at all times, and would be accessible by a simple reach of the hand rather than to require a full-arm sweep to reach them, as is common with the feathering button installations in most airline airplanes. The original idea of installing feathering buttons in as inaccessible a spot as possible, to prevent them from being activated inadvertently, has long been known to be outmoded and absurd. Prop feathering is definitely a part of fire control in an engine, and the feathering controls should be treated accordingly.

Overhead panel showing position of feathering buttons which pilots would like to have relocated at a point below glare shield.
