**ASSESSING SEDIMENT DYNAMICS AND CHANNEL BAR RESPONSE
IN THE BRAZOS RIVER NEAR GLEN ROSE, TEXAS**

**Submitted to the Graduate Faculty of the
College of Science and Engineering
Texas Christian University
In partial fulfillment of the requirements
for the degree of**

Master of Science

May 2012

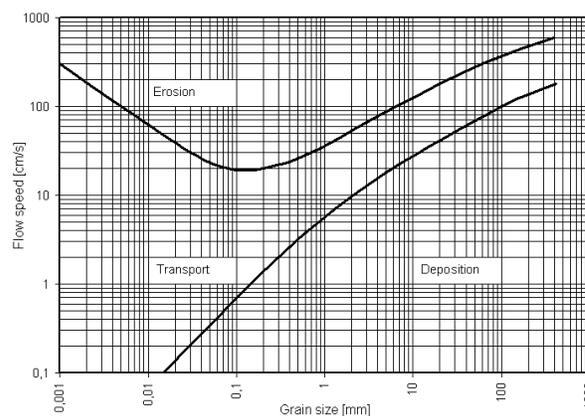
Figure 1. Relationship between the entrainment, transport and deposition of material of varying particle sizes described by Hjülstrom (1939)

To initiate sediment transport a particle must first experience entrainment. The degree of entrainment depends on the critical bed velocity as well as the critical shear velocity, or erosive power of the flow. Hjülstrom (1939) described the transport and deposition of material according to particle size and velocity. Figure 1 shows that a relatively low mean velocity is required to transport silt to fine sands. Additionally, for fines the entrainment and settling curves show a significant separation. This suggests that a substantial decrease in mean velocity may not cause material to fall out of suspension. Coarser grained material requires a higher mean velocity to initiate entrainment. Furthermore, the spacing between the entertainment and settling curves suggest that a small decrease in mean velocity may cause deposition of the material.

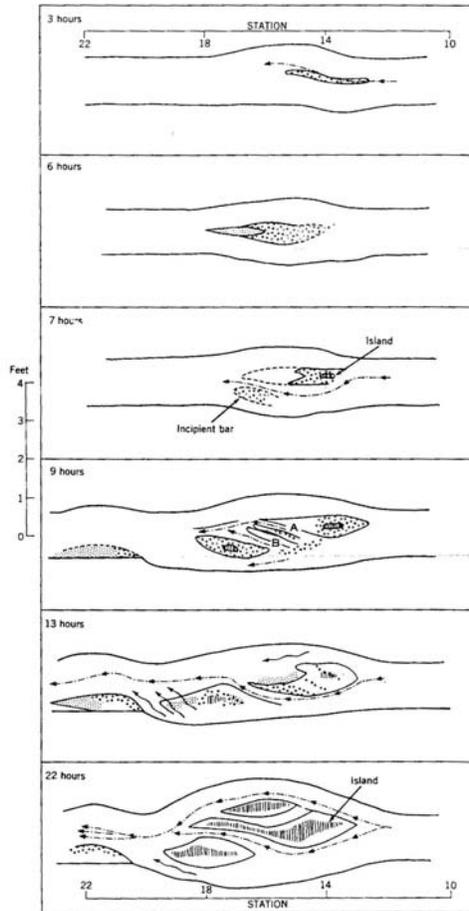
Figure 2. Channel bar development as described by Leopold and Wolman (1957)

where I equals the total input to the system, and O describes the output. The difference between the input and output is ΔS , or the change in storage. This relationship suggests that if sediment input to the system exceeds sediment output there is a positive net change in storage (Ritter 2002). Hungry water found in the reaches below a dam has the increased the potential for scouring and erosion due to excess energy. Material from affected regions may be transported and deposited in reaches downstream and create areas of storage in the form of channel bars. A Leopold and Wolman study (1957), confirmed by Lisle (1982), determined that initiation of channel bar growth is due to deposition of coarse material that exceeds the river's ability for transport (Figure 2). Vertical bar aggradation and lateral growth occurs downstream. As water is forced around the newly formed structure, channel banks experience increase scour and may cause the channel to locally widen. A deepening of the channel bed lowers water levels allowing the channel bar to emerge as an island.

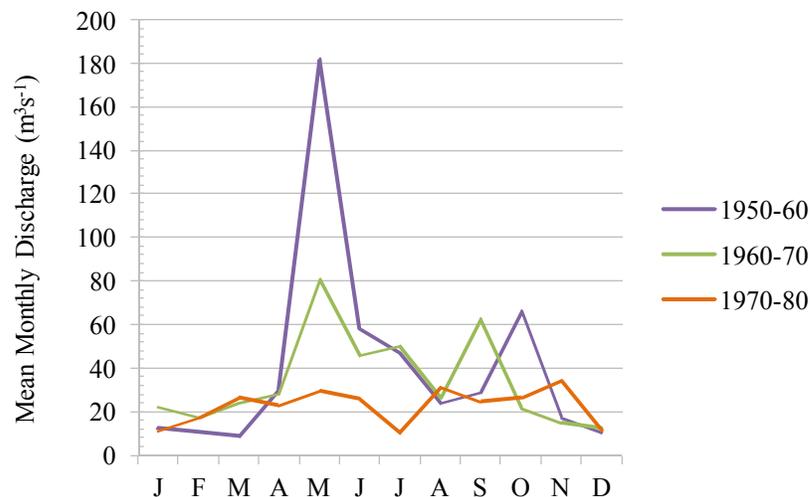
Figure 8. Analysis of mean monthly Q for pre-and post-impoundment flow conditions

The availability of a historic discharge record allowed for the comparison of flow trends at the study site pre- and post-dam construction. To establish an initial understanding of peak flow alteration due to the construction of the dam, mean monthly discharge rates were obtained for 1950 to 1980 (Figure 8). The record was subdivided into 3 individual intervals, spanning conditions before construction, as well as during and after construction. Under natural flow conditions, 1950 to 1960, this specific reach of the Brazos experienced peak flows during the spring and fall with the highest peak observed during the spring. A significant dampening of the spring peak is visible during the construction period. The post construction curve, 1970 to 1980, depicts a near elimination of seasonal peaks creating a more uniform annual flow.

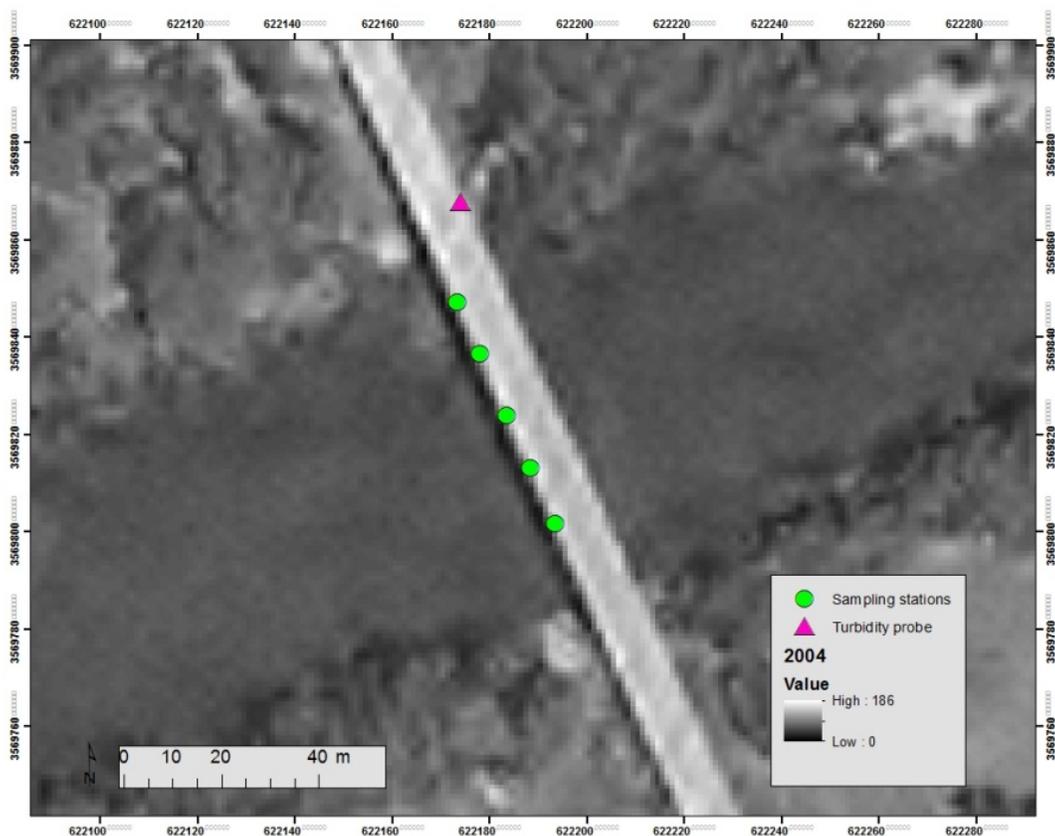
Figure 9. Sediment sampling stations and gaging station on FM 200 Bridge

and remained onsite for the duration of the research period. To establish a relationship between turbidity readings and the actual quantity of sediment transported, suspended sediment samples were obtained over a range of flow conditions. It must be taken into account that suspended sediment concentrations vary from the water surface to the bed and laterally across the stream. Concentrations generally increase from a minimum at the water surface to a maximum at or near the bed (Kondolf 2003). To capture this variability a US D-74 depth integrating sampler was used at 5 individual bridge stations across the channel (Figure 9 and 10).

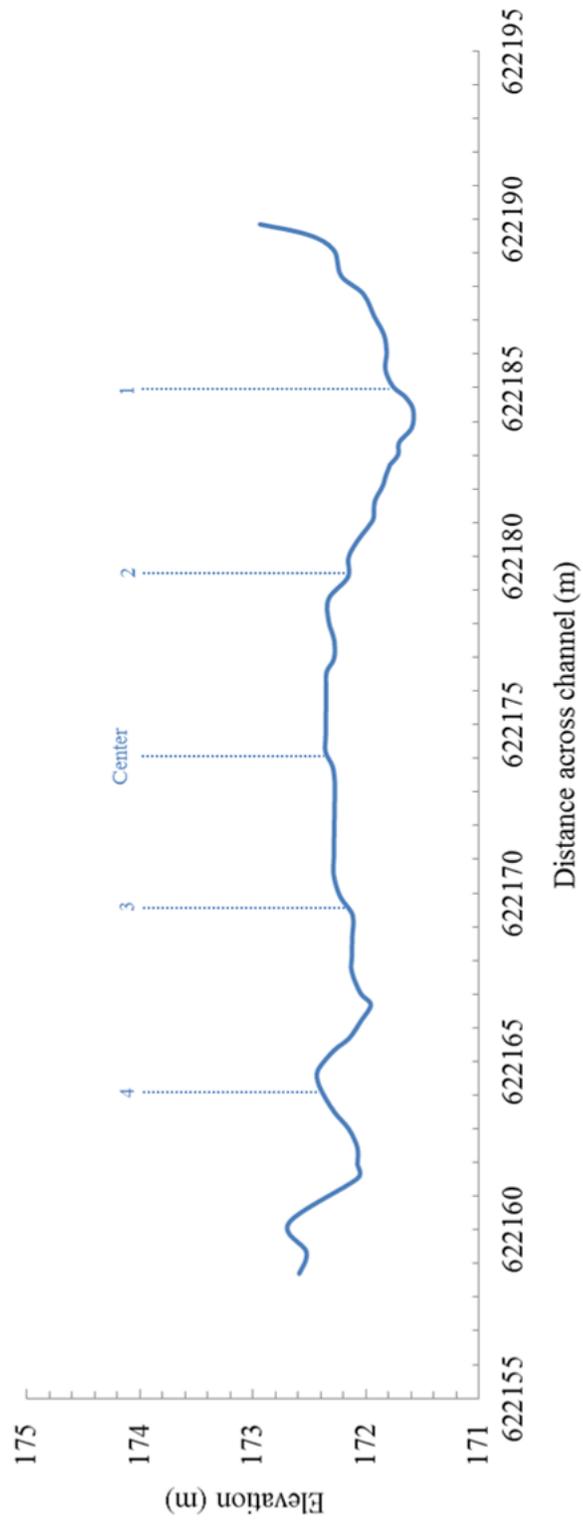
Figure 10. Channel cross section, completed in October 2011, showing locations of sampling stations across the FM 200 Bridge

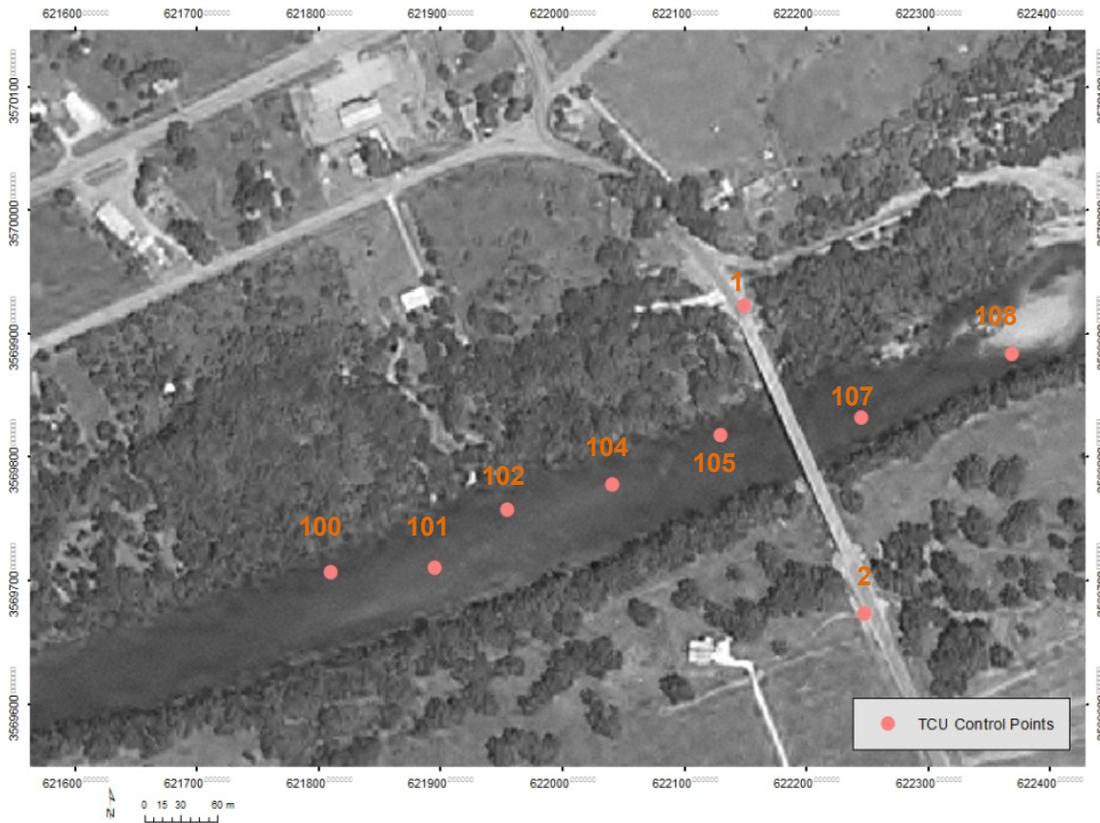
Figure 11. Location of permanent control points along the study site

To obtain an accurate baseline survey, a Leica Scan Station c10 was used in April 2011. This technology is capable of capturing high-density point cloud data and imagery to an accuracy of 3mm per 100 meter. Long range scanning technology successively sends out thousands of pulsed beams of light while the system calculates the time of travel from departure to arrival back at the unit. Mirrors determine the beams horizontal and vertical angles to establish highly accurate x, y and z coordinates. The Leica Scan Station c10 has the ability to capture over 10,000 points per second (Leica). For this survey permanent control points were established at 9 individual locations, 2 control points are found at the FM 200 Bridge and 7 spanning the length of the channel bar (Figure 11). In order to maintain consistency throughout the project, control points were used in all subsequent surveys.

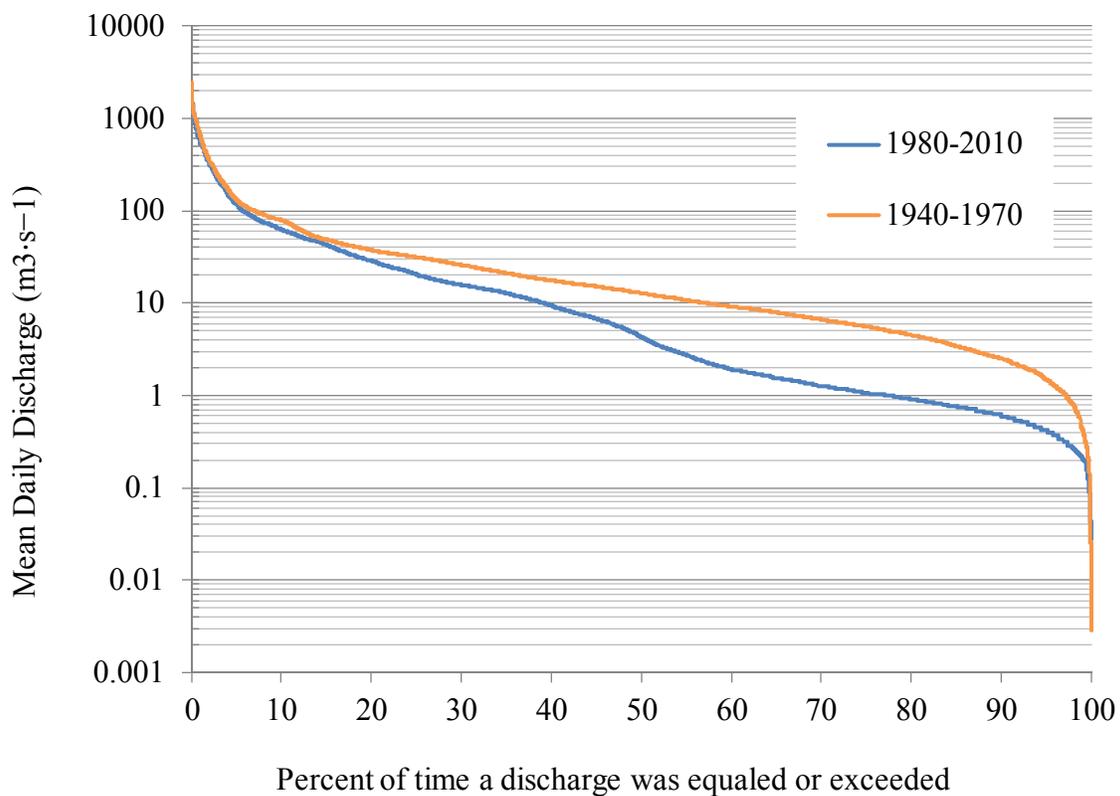
Figure 12. Flow duration curves showing flow trends before and after construction of the dam

where m equals the ranked position and n is the number of events for the period of record (Dingman, 2008). High flow events are generally represented in the 0 to 10% exceedance range, moist conditions between 10 to 40%, mid-range flow 40 to 60%, dry conditions 60 to 90%, and low flow events within the 90 to 100% exceedance range. For the study area it was determined that median discharge rates ($Q=50\%$) decreased from $36 \text{ m}^3\text{s}^{-1}$ pre-construction to $22 \text{ m}^3\text{s}^{-1}$ post construction (Figure 12).

Historic variability and trends in Q may be described with the use of a flow duration curve. For the study site, a pre- and post-impoundment curve was established. (Figure 12). The introduction of the dam at Lake Granbury caused the mid-range flow conditions or discharges in the 40% to 60% exceedance probability range to decrease. Pre impoundment flow were $39 \text{ m}^3 \text{ s}^{-1}$ and $32 \text{ m}^3 \text{ s}^{-1}$ respectively across this range, whereas post impoundment rates declined to $9.3 \text{ m}^3 \text{ s}^{-1}$ and $1.8 \text{ m}^3 \text{ s}^{-1}$. Median flow (i.e. the 50% exceedance probability) equaled $12.8 \text{ m}^3 \text{ s}^{-1}$ before the construction of the dam, and $4.3 \text{ m}^3 \text{ s}^{-1}$ for the post impoundment period. This equals a lowering of the median flow by $8.5 \text{ m}^3 \text{ s}^{-1}$, or 34%. Before the construction of De Cordova Bend Dam, flow exceeded $20 \text{ m}^3 \text{ s}^{-1}$ 38% of the time. Under post impoundment conditions the same flow is only exceeded 24% of the time. Similarly, flow conditions exceeding $10 \text{ m}^3 \text{ s}^{-1}$ occurred 54% of the time pre-dam construction versus 39% post-dam. It would be expected that the construction of the dam increases low flow ranges as peak discharges are dampened or

eliminated. However, the flow duration curve for this section of the Brazos suggests that even after the construction of the dam, low flow conditions had a lower occurrence frequency compared to pre dam conditions. This trend is most likely the result of increasing water allocation demands from surrounding cities with growing populations. The introduction of the dam into the river system produced an overall lowering of median discharge rates. As transportation and entrainment of sediment is directly related to discharge, it may be suggested that by lowering Q , and therefore ω , the river's ability to transport material decreases.

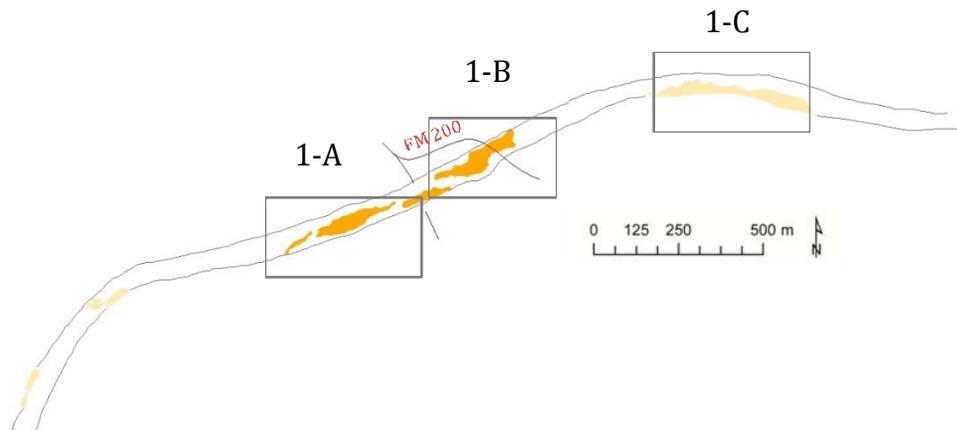
Figure 13. Locations of individual channel bar complexes along study reach

To understand historic channel bar morphology, the obtained aerial photographs were digitized to allow for visual analysis. The channel bars along the study reach were divided into bar 1-A, 1-B, and 1-C (Figure 13). Each of the individual channel bars was analyzed for areal change. Directly comparing the extent of the bars between 1949 to 1984, suggests that even though bar area may have fluctuated the overall location of the channel bars in the study reach as well as river channel have remained relatively stable (Figure 14). It is important to note, however, that flow levels vary between each photograph and therefore the degree to which the bar is inundated or exposed varied. For example, the earliest photograph dating to 1949, was taken on March 9th when the mean daily Q equaled $4.53 \text{ m}^3\text{s}^{-1}$ which corresponds to a contemporary gage height of 1.62 m. The data from USGS gaging station 08091000 suggest that the photograph taken in 1959, on Feb. 6th, shows a mean daily Q of $6.63 \text{ m}^3\text{s}^{-1}$ which currently would produce a gage height of 1.64 m. This produces a difference of 0.02 m in gage height between the two photographs.

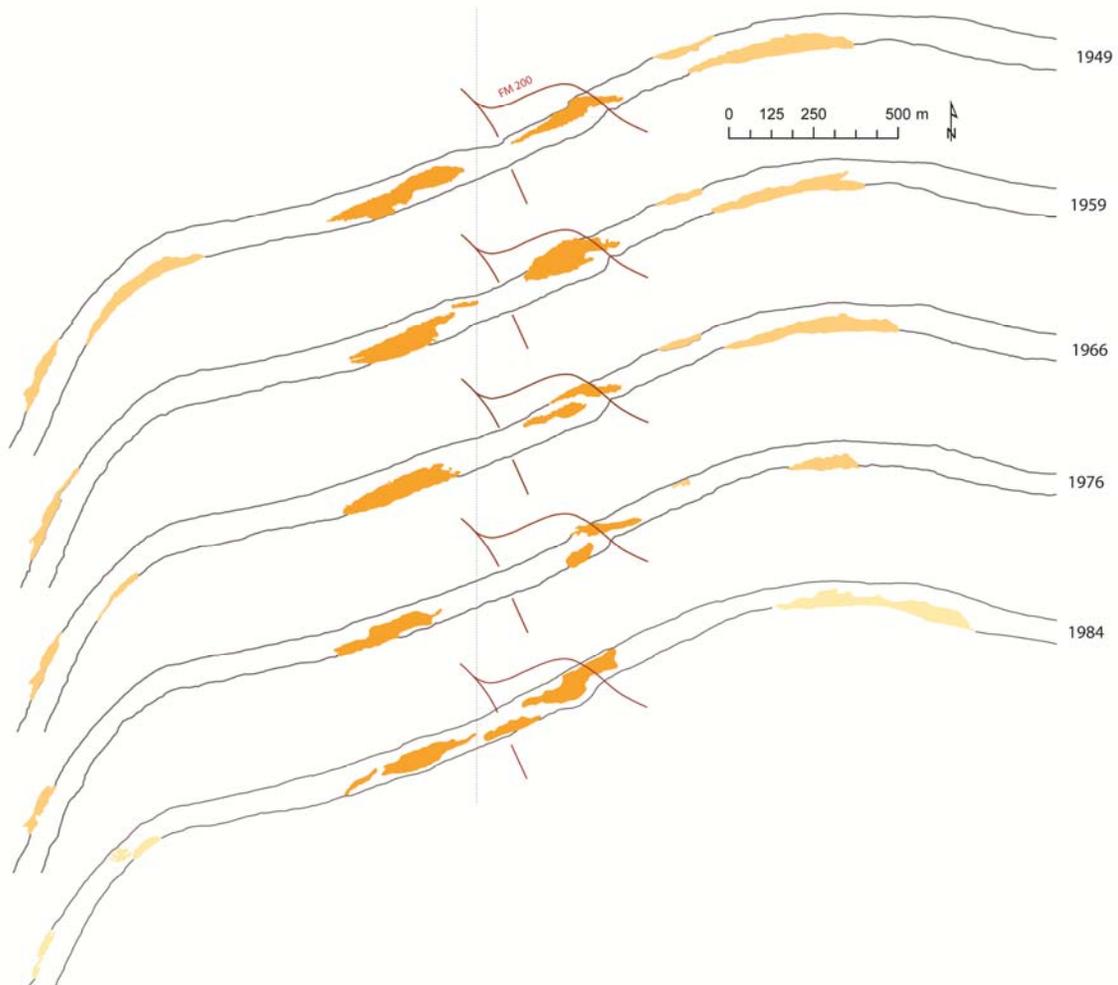
Figure 14. Visual comparison of channel configuration and bar locations established from historic photography (1949 to 1984)

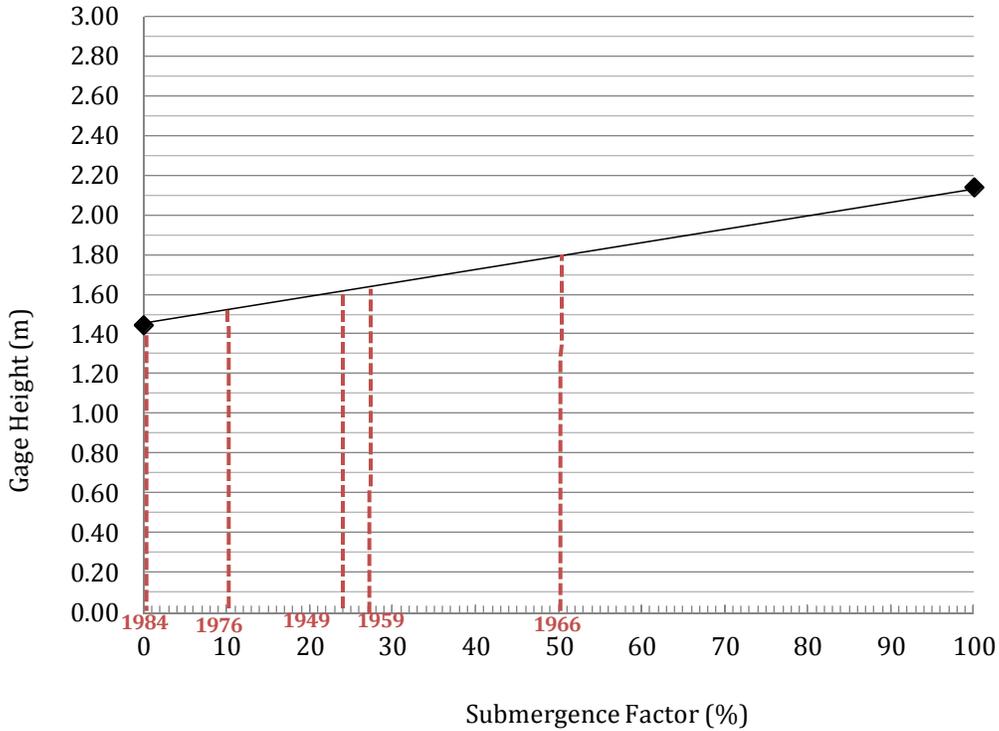
Figure 15. Inundation curve used to establish corrected channel bar areas

correspond to a gage height of 1.45 m. These conditions exposed the entire downstream channel bar. Discharge rates under which the entire bar was inundated equaled $32.85 \text{ m}^3 \text{ s}^{-1}$ with a gage height of 2.14 m. This suggests that it requires an increase of gage height equivalent to 0.69 m to completely inundate the downstream portion of the channel bar. Knowing the two endpoints, an inundation curve shown in figure 14 was established where a gage height of 1.45m corresponds to 0% inundation and 2.14m corresponds to 100% inundation. As all obtained photographs were received with metadata including accurate information of date and time when the image was taken, the necessary USGS flow data could be obtained. Each year was then placed on the inundation curve according to the specific flow conditions shown in each image. Even though the gaging station has a long-term record for Q, dating back to 1923, the same is not true for gage height. The stage data record for the study area commences in 1988 and therefore a stage-discharge relationship can only be established between 1988 to the present. Comparing stage-discharge between 1992 and 2000, and 2000 to 2008 suggest only a slight shift in the relationship over a 16 year period. However, it is uncertain if the relationship will hold true over a multiple decadal time scale. Matching contemporary stage measurements with historic discharge events may introduce a degree of error in the determination of bar inundation rates.

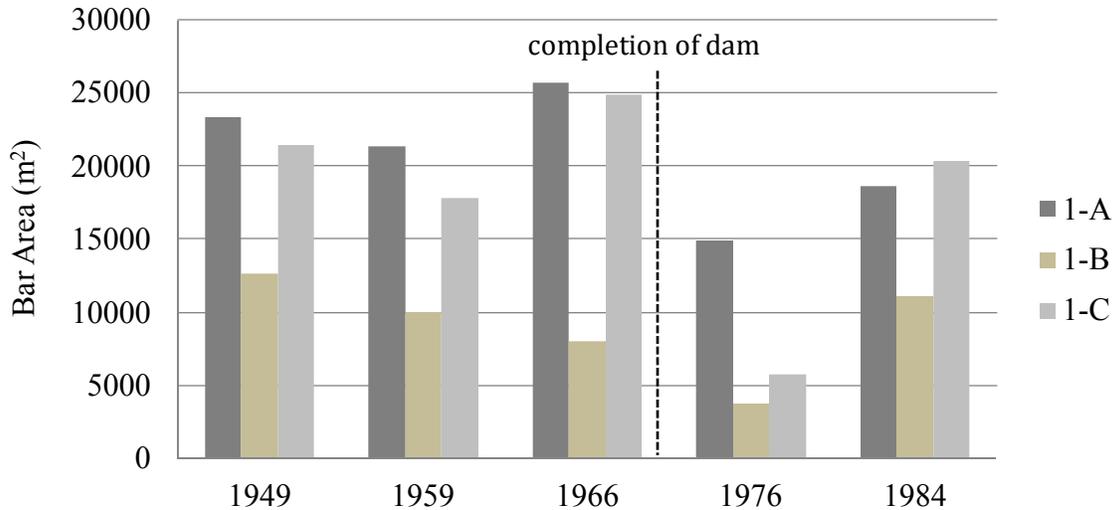
Figure 16. Comparison of channel bar area across the reach for each of the historic images

Numerous studies have shown that large amounts of sediment may become trapped behind a dam structure producing sediment starved waters downstream (Graf, 1999; Kondolf, 1997). This initial imbalance in sediment supply may result in increased scouring of downstream reaches as the river attempts to readjust its sediment load. Even though the natural sediment delivery ratio is altered by the construction of an impoundment, large amounts of sediment can still become mobilized due to the increased erosive force of the water released downstream. An increase of sediment supply due to prolonged scouring may be responsible for the observed overall channel bar growth in the 1984 historic photograph, and change observed in bar 1-C.

Similar trends are observed for channel bar 1-B and 1-C in the upstream reaches of the study site (Figure 16). A stable channel bar is calculated for the pre-construction period from 1949 to 1966 with a sharp decline in bar area post-construction for both 1-B and 1-C. Channel bar 1-B shows a reduction in bar area of 54%, whereas channel bar 1-C declined by 77%. All three channel bar complexes show an areal increase in 1984. Changes in bar morphology are directly related to the available stream power. It is therefore necessary to compare storage changes to observed annual flow trends (Figure 17). In the comparison of 1949 and 1959, a decline of bar area is observed in the entire reach. When combining this trend with specific annual discharge over the same time frame, it becomes evident that a significant discharge event in 1957 could be responsible for the shift. In May of 1957 discharge rates reached a maximum of $2400 \text{ m}^3 \text{ s}^{-1}$, with elevated flow levels sustained for most of the month. As this period marks a pre-impoundment channel, flow was not regulated and therefore peak flows attained. A significant increase in discharge will raise stream power and the river's ability to flush

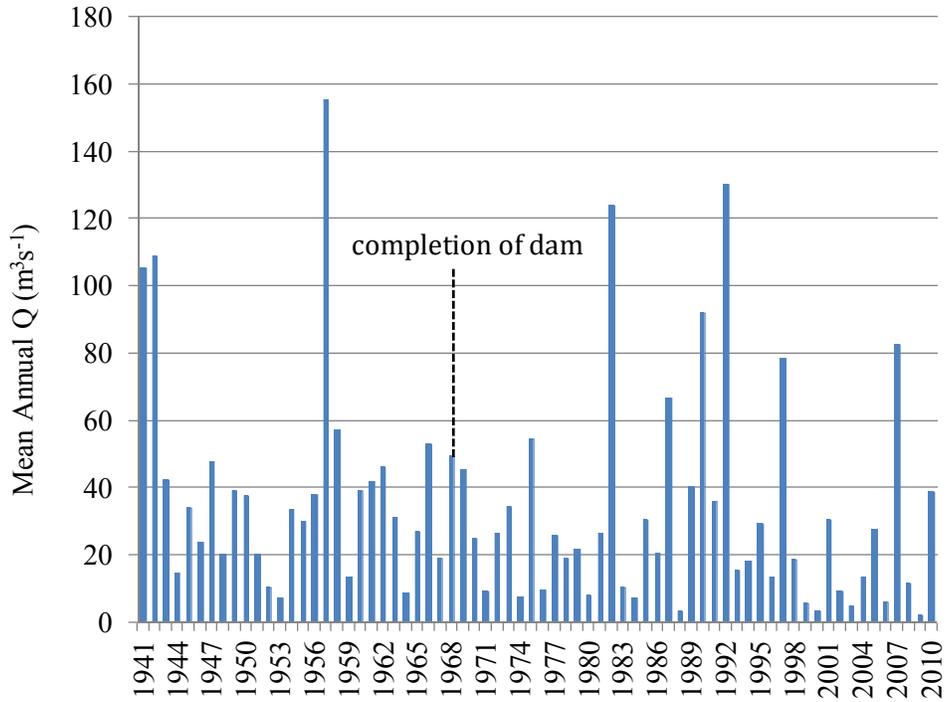
Figure 17. Fluctuations in mean annual discharge rates at the study site 1941 to 2010

stored sediments. A second trend observed between the three channel bar complexes is a steady growth from 1976 to 1984 (Figure 17). This increase in bar area follows the sharp decline observed in the initial post impoundment phase. It might be suggested that an initial reduction in sediment load is responsible for the decline observed in 1976. The growth in 1984 can be explained by either increased sediment mobilization due to scouring below the dam or by variations in climatic conditions. A comparison with the annual discharge trends shows a second significant flow event occurred in 1982. In June of 1982, maximum flow levels were recorded at $1280 \text{ m}^3 \text{ s}^{-1}$, with elevated discharges recorded mid-May through early July. Prolonged precipitation and erosion can significantly increase sediment supply in the reach below the dam. As flow was regulated during this period it is unlikely that natural peak flows were attained. Flow regulation alters the natural hydrograph of a river by potentially increasing the slope of the rising limb while extending the length of the recession limb. Sediment deposition occurs along the recession limb as flow slows down and material can no longer be held in suspension or transported along the bed.

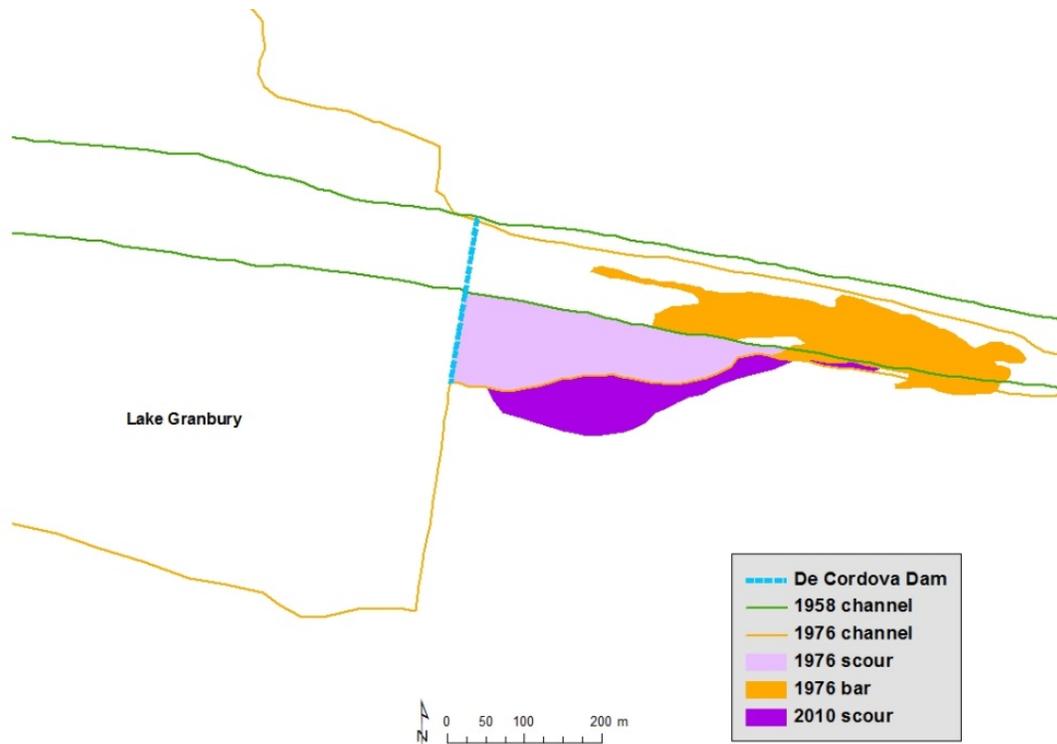
Figure 18. Channel scour for post construction years observed through photographic analysis

In order to determine the validity of the assumption of increased sediment mobilization below the dam, two additional aerial photographs were obtained showing the exact location of De Cordova Bend Dam in 1958 and 1976 (Figure 18). A significantly scoured region was observed below the dam in 1976, with an areal extent calculated to 2,448 m². An additional comparison to a 2010 photograph suggests continued scouring, increasing the affected area to 3,784 m². However, in addition to bank erosion and scour there is also evidence of bar formation in 1976. A substantial bar complex was measured to comprise 2,851 m². There is no evidence of the same bar formation in 1958.

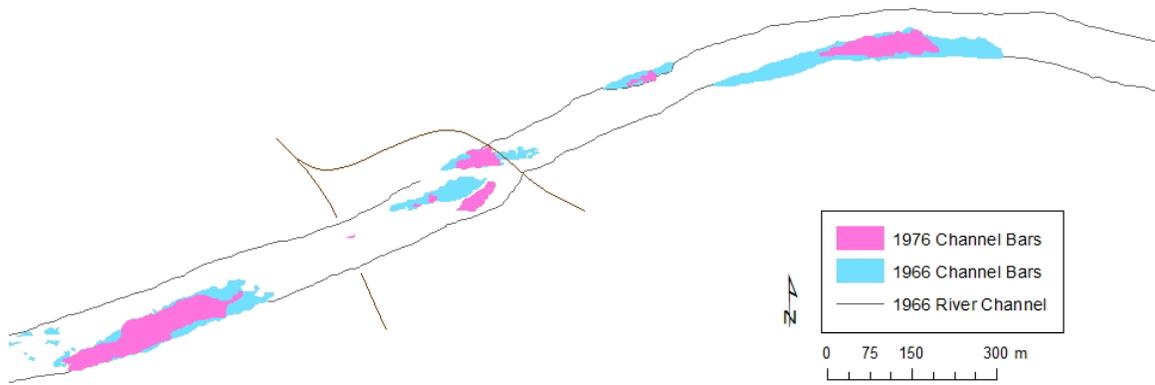
Figure 19. Comparison between channel bar locations 1966 to 1976

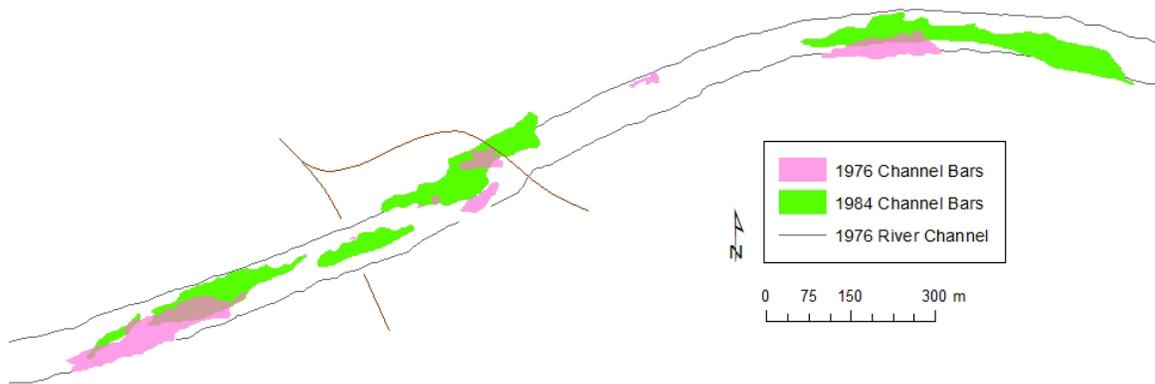
Figure 20. Comparison between channel bar locations 1976 to 1984

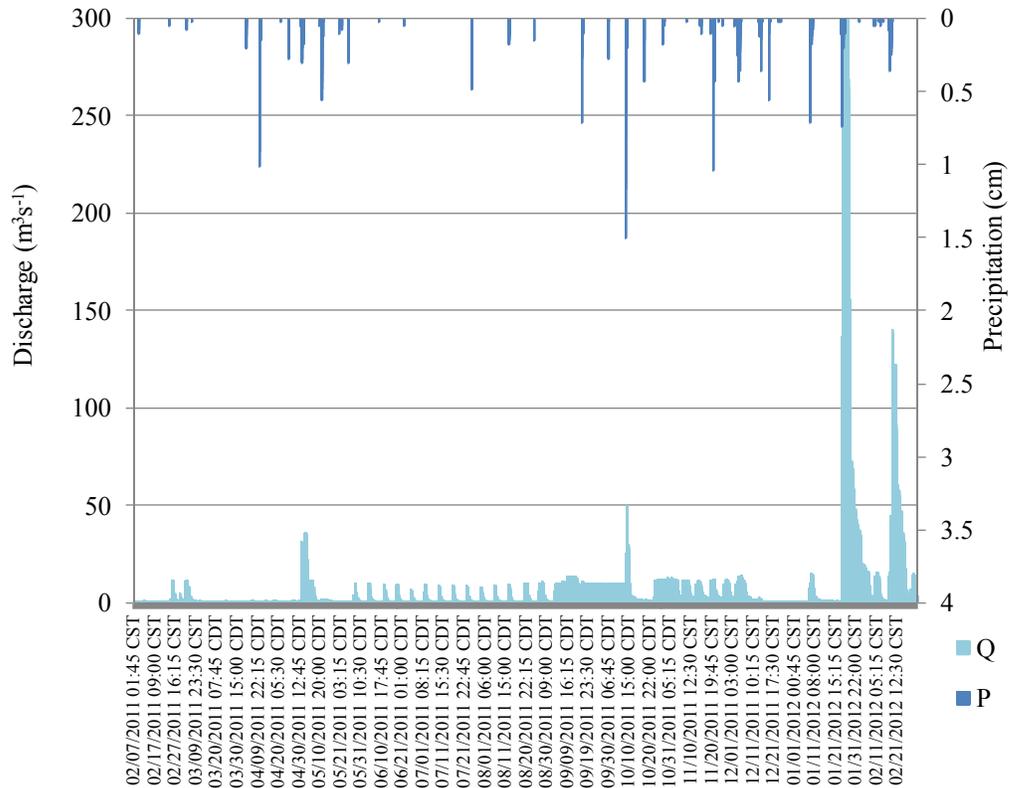
Figure 21. Discharge trends for February 2011 to March 2012 compared with rates of precipitation

2011 marked a year of extreme drought for large parts of Texas. The state experienced a combination of record setting temperatures and low precipitation rates. Discharge levels in the Brazos were reduced and sustained for much of the summer and fall. With low precipitation rates during these months, gage height fluctuated between 1.50 m to 1.75 m (Figure 21). Successive patterns in rising and falling stage from May 2011 to December 2011 marks periods of controlled dam release. Due to extensive drought conditions, the Brazos River Authority continuously released water from Lake Granbury to relief shortages in downstream reaches. The single substantial increase in discharge and stage was observed during late January 2012 when the area received nearly 11 cm of rainfall over a 48-hour interval. In order to establish short-term change in morphology, channel bars were repeatedly surveyed. The initial plan included an extensive survey to be completed every two months throughout the study period. However, due to the lack of variation in flow conditions surveys were obtained March 2011, April 2011, October 2011, and March 2012.

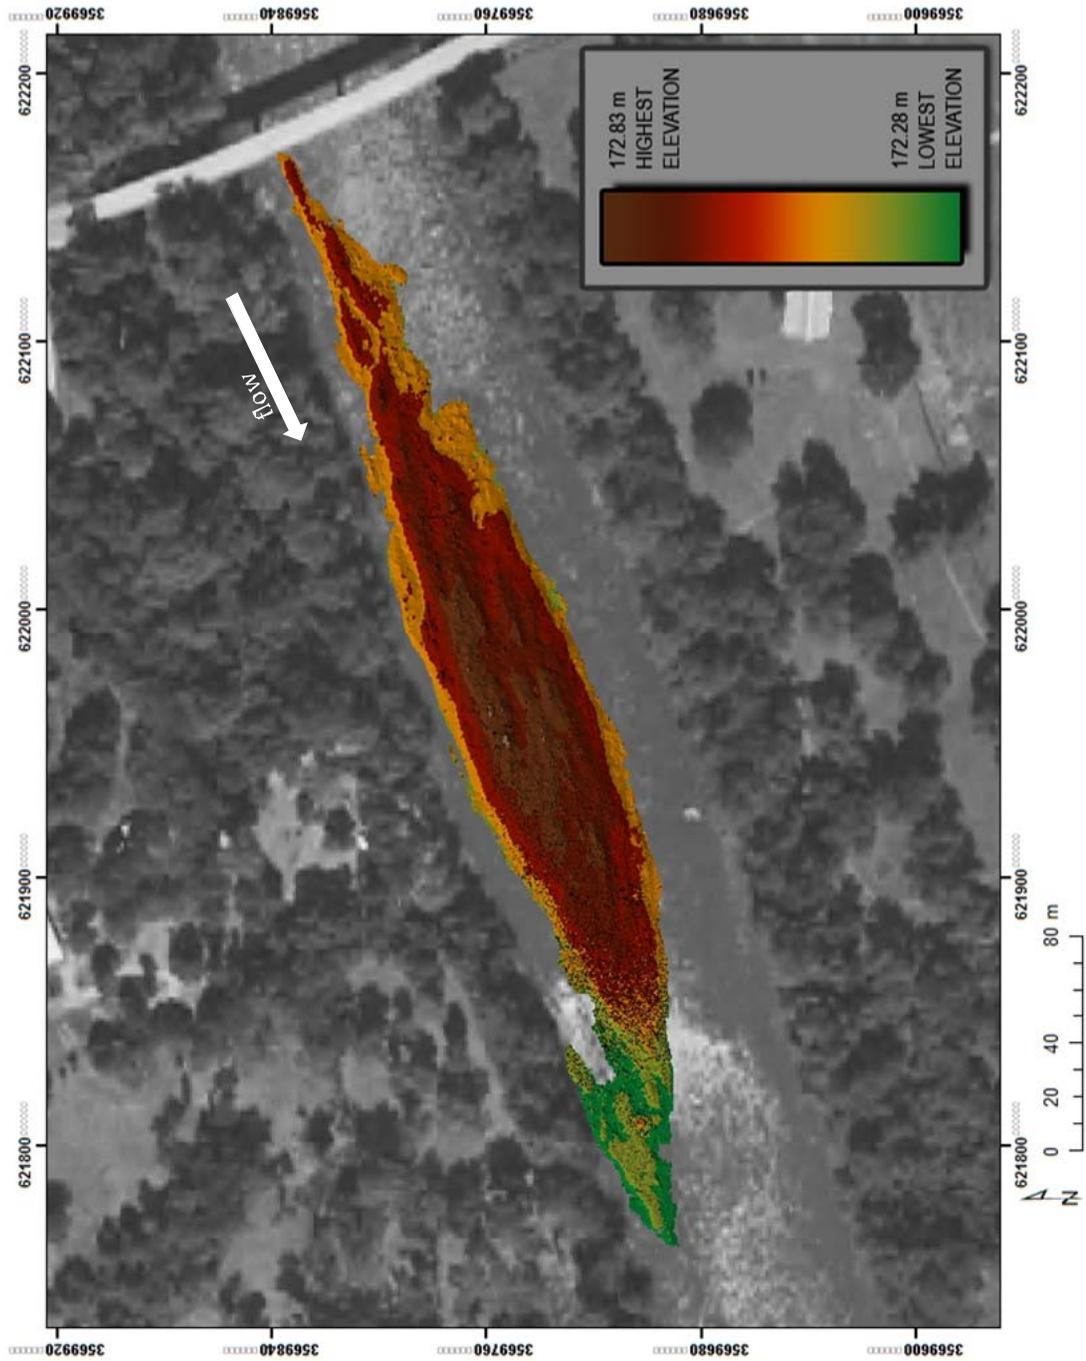
Figure 22. April 2011 Terrain data model showing range of elevation across the mid channel bar

obtained during the April 2011 baseline survey suggest a planform area of 19,360 m² and a volume of 22,928 Mg at a plane height of 171.73m. This survey allowed for the accurate determination of variation in topography across the channel bar, establishing that the range in elevation varies between 172.83 m to 172.28 m. A terrain data model established with the survey data suggests that bar accretion occurs laterally towards the mid sections of the bar, and lowest elevations are found in the lower bar reaches (Figure 22).

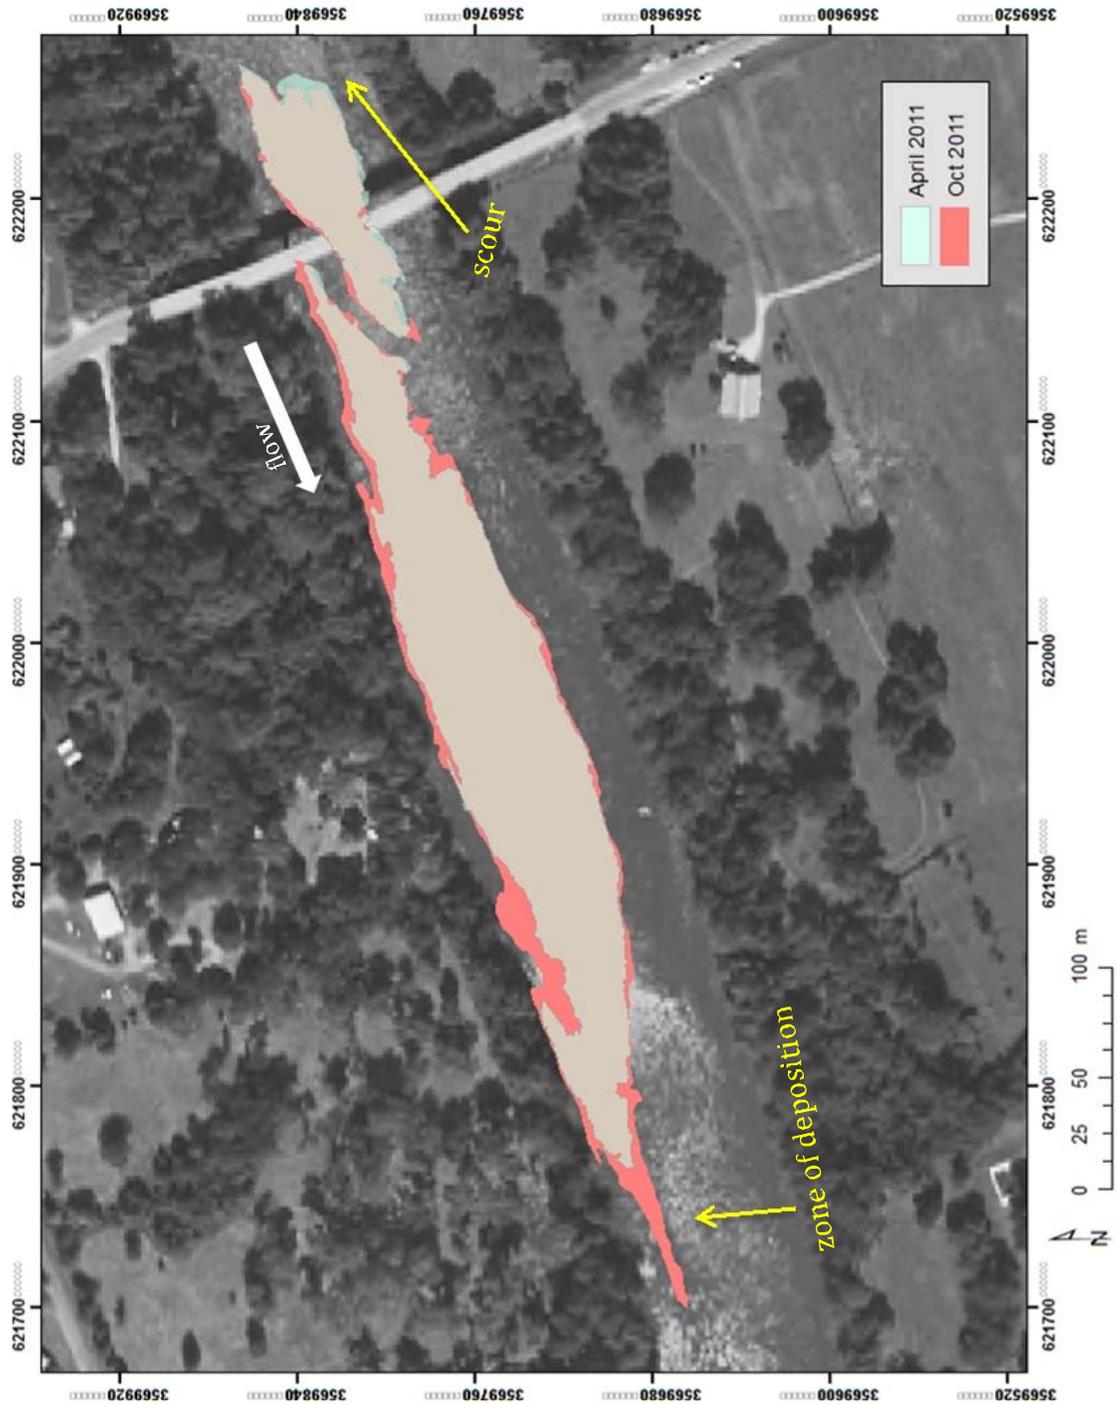
Figure 23. Overlay of April 2011 and October 2011 surveys showing areas of scour and deposition

As with the photography time series analysis, specific flow conditions must be taken into account when comparing between surveys. With the use of the same inundation curve it was established during the April 2011 survey that 9.6% of the channel bar was inundated and therefore the actual bar area exceeded what was measured during the survey. The revised channel bar area equaled 21,219 m². Subsequently, the second survey completed in October 2011 was obtained at a gage height of 1.45m. According to observations made over the duration of the study period, this gage height marks a 0% inundation rate. Therefore, the area obtained during the survey did not have to be adjusted to include inundated sections. For this survey, planform area measured 22,142 m². This suggests a slight increase in bar area of 924 m² between April and October 2011. The apparent change may be explained by reduced stream power due to low flow conditions, and therefore the reduced ability to transport material downstream. Some evidence of scouring is visible at the upstream portion of the bar (Figure 23). This area is considered the bar head and is subjected to flows of highest velocity and erosive capability. Extreme downstream portions of the bar appear to show increased deposition. Again, it must be taken into consideration that surveys were completed under varying

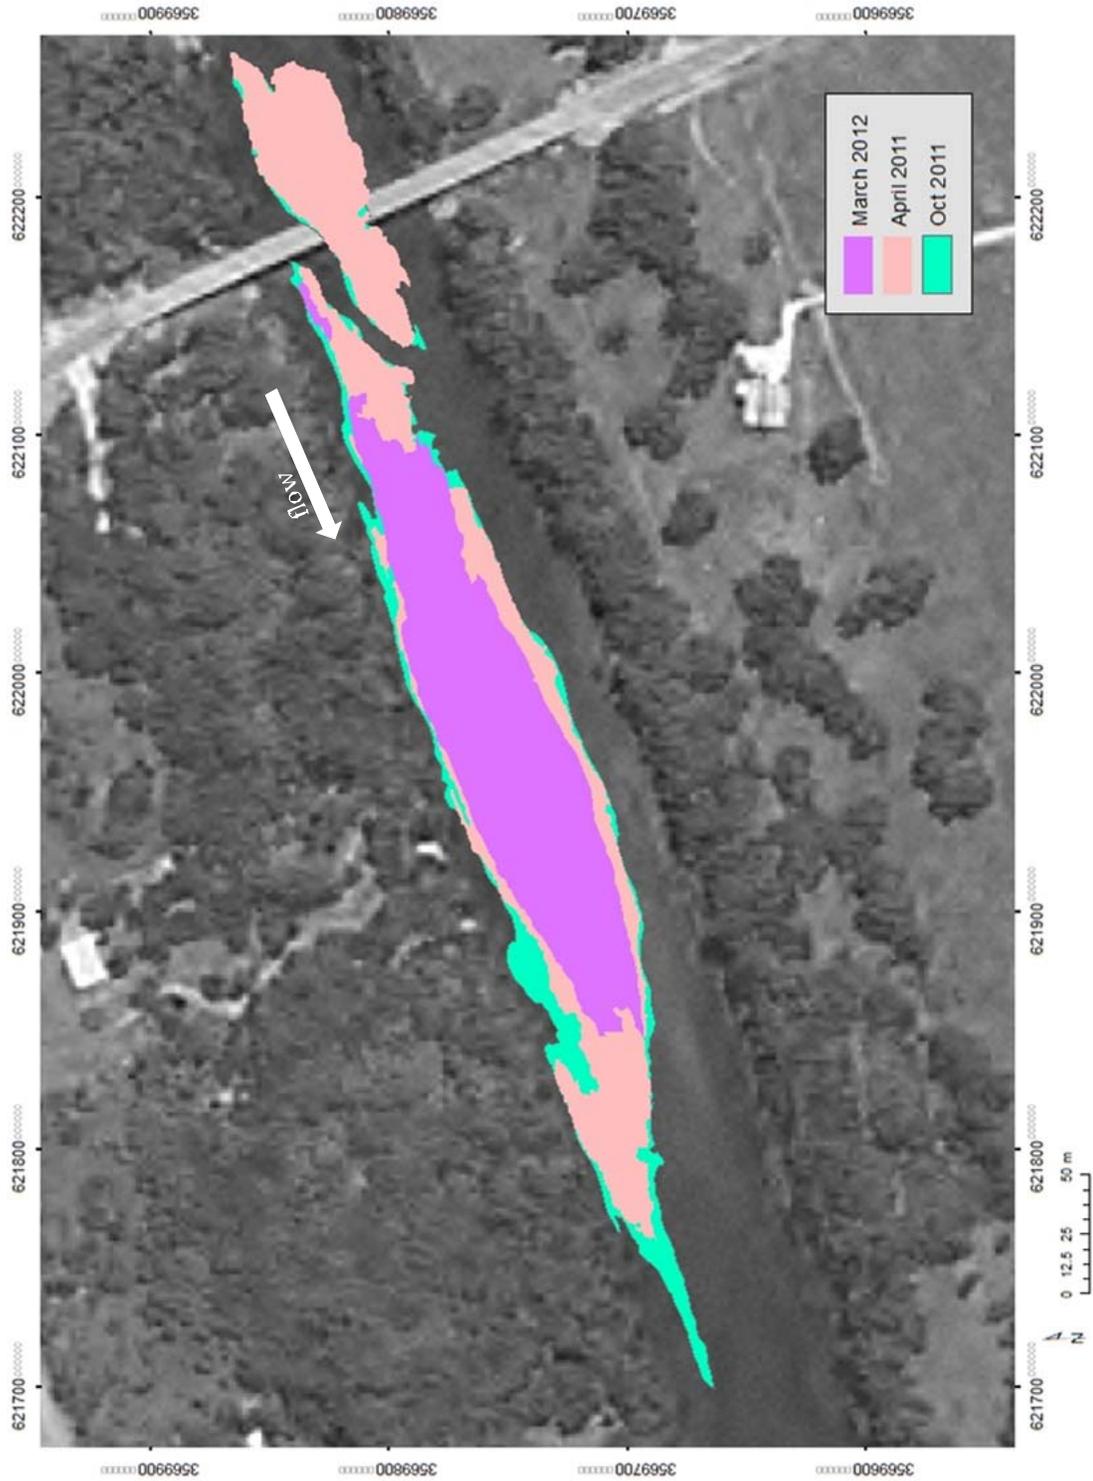
Figure 24. Overlay of completed surveys April 2011, October 2011 and March 2012

A fourth and final survey was completed on March 4th 2012 at a discharge of 3.25 m³s⁻¹ and gage height of 1.59 m (Figure 24). Ideally, the survey would have shown channel bar extent over low flow conditions. Due to infrequency of these events during spring months this was not attainable. The entire channel bar area could not be surveyed as higher inundation rates covered upstream portions of the bar. With the use of the inundation curve, planform areal measurements obtained during this survey were revised to suggest a significant decrease in bar area of 6,047 m² from October 2011 to March 2012 (Table 4). This establishes a decrease of approximately 33%. A substantial storm event experienced in late January 2011 is most likely responsible for the majority of this change. High discharge rates for this event exceeded a 1991 record and greatly increased stream power, therefore increasing sediment entrainment and transport.

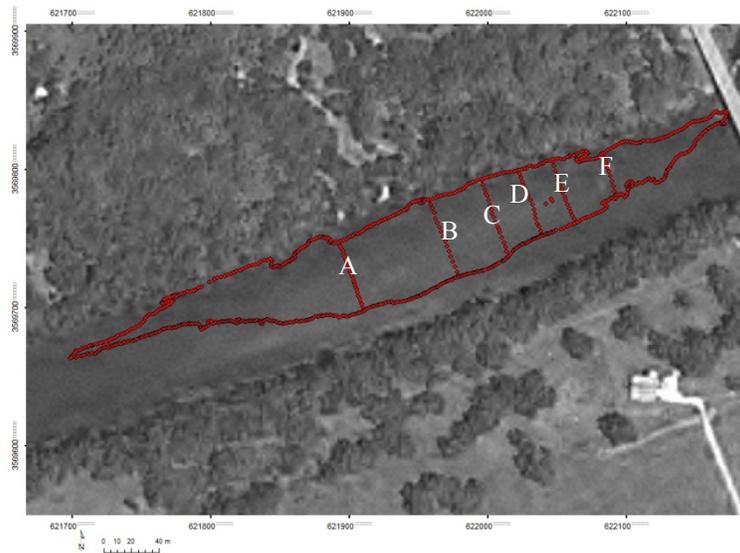
Figure 25. Location of transects for October 2011 and March 2012 surveys

Additionally to establishing a new channel bar perimeter, the March 2012 survey aimed at reconstructing previously determined transects across the lower portion of the bar (Figure 25). The exact location of these transects were determined with the use of a GeoXH unit. Transects were then re-walked to determine change in Z. Newly obtained elevations could be compared with October 2011 data to determine the degree of aggradation and degradation across the channel bar after a substantial storm event.
