**ASSESSING SEDIMENT DYNAMICS AND CHANNEL BAR RESPONSE
IN THE BRAZOS RIVER NEAR GLEN ROSE, TEXAS**

**Submitted to the Graduate Faculty of the
College of Science and Engineering
Texas Christian University
In partial fulfillment of the requirements
for the degree of**

Master of Science

May 2012

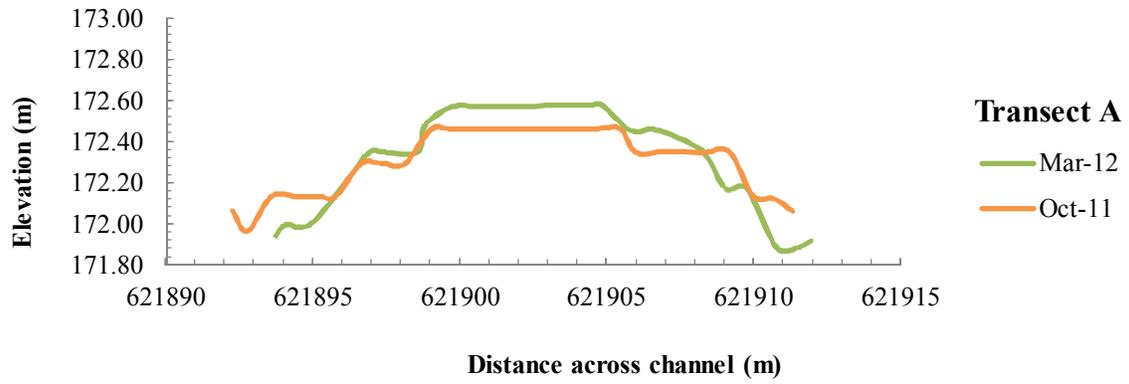
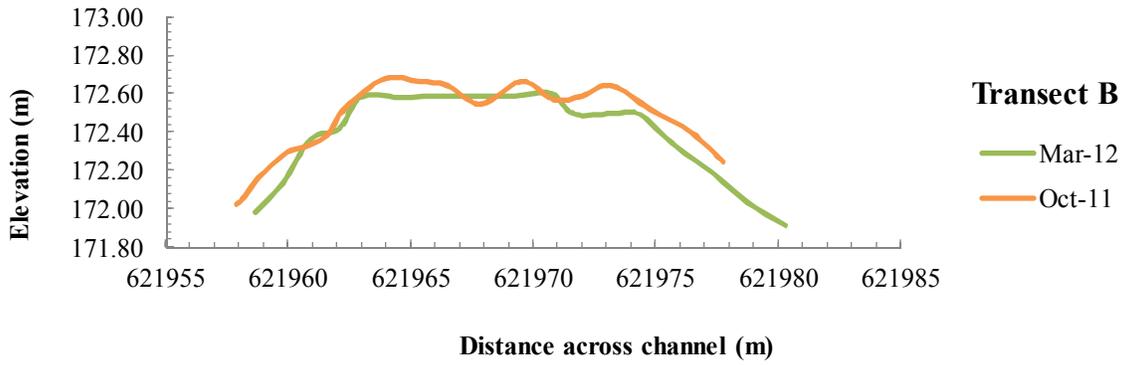
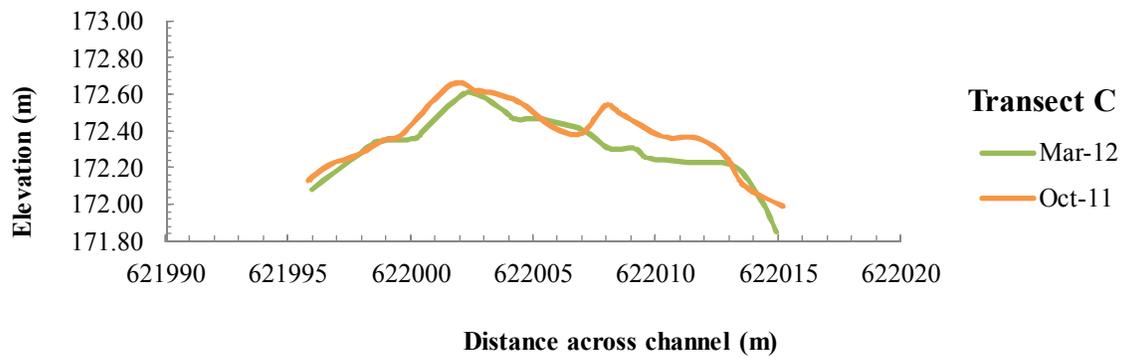
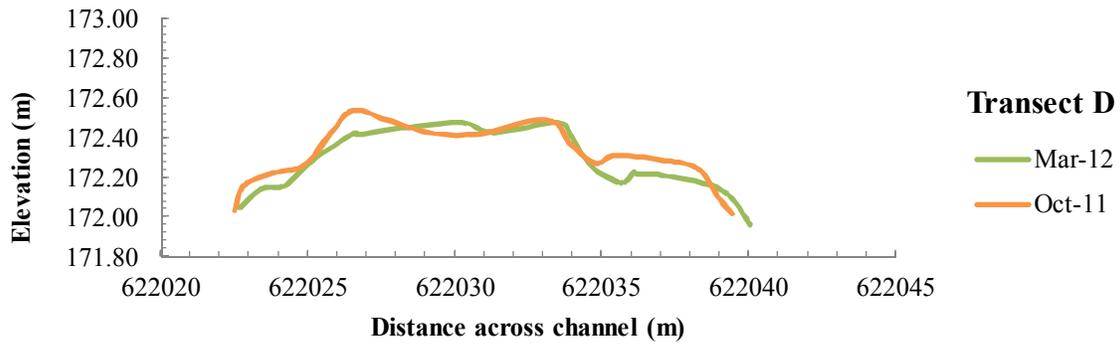
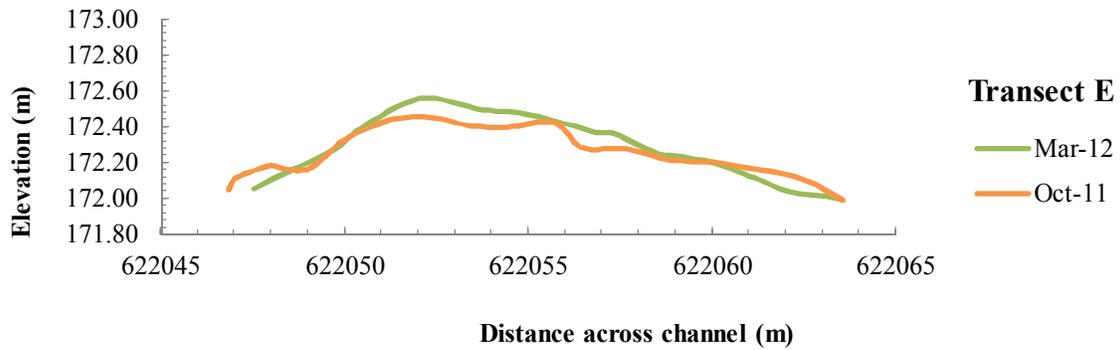
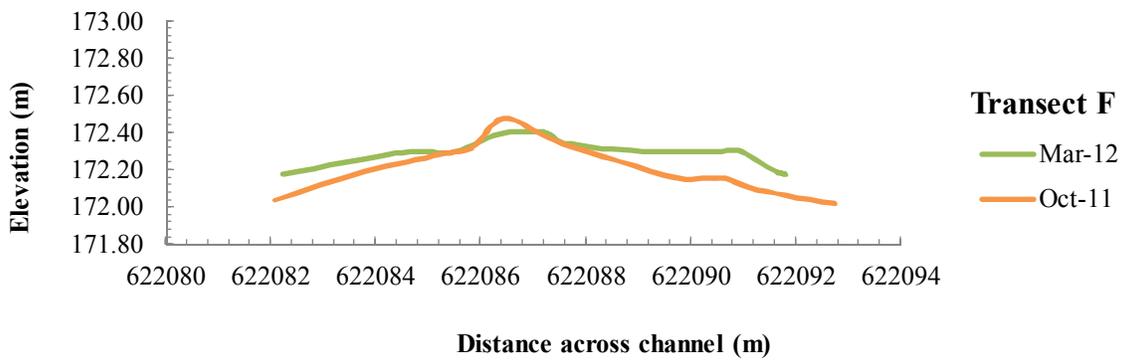
Figure 26. Comparison of 6 transects across the channel bar showing topography change from October 2011 to March 2012

Transect A, along the lowest reach of the bar, shows evidence of aggradation along the midsection and degradation along the edges and bar slopes (Figure 26). With the use of the trapezoidal method, areas below the individual transect curves were

determined and compared to determine change between October to March. Even though transect A shows areas of aggradation and degradation, a net increase in area was calculated to 0.79 m^2 along this transect. In general, a substantial storm event is expected to remove material along the edges as well as the top of the bar. Evidence of edge trimming is visible; however, aggradation along the top and midsection of the bar may be due to increased sediment deposition along the recession limb of the storm. During this period, discharge tends to decrease and therefore stream power, or the river's ability to transport material, decreases. On the recession limb, material availability may not be completely depleted and deposited material can produce substantial aggradation across the bar top.

Varying rates of degradation are observed between transect B to D, or the midsection of the bar. Degradation along transect B was calculated to 2.43 m^2 , and along transect C to 1.73 m^2 , and transect D to 0.15 m^2 . However, along the upper reaches, or along transect E and F, evidence of aggradation is observed. This area signifies the zone which is most susceptible to erosive high discharge events, as it is the initial point where flow impacts the structure and considered the bar head. Therefore, velocity is highest along these reaches of the bar and slows across the length of the bar due to shallowing water depth and increased friction. Degradation would be also expected along this part of the bar and most likely occurred during the storm event; however, with decreasing discharge rates along the recession limb and subsequent lower flow conditions may be responsible for the visible building up of the profile.

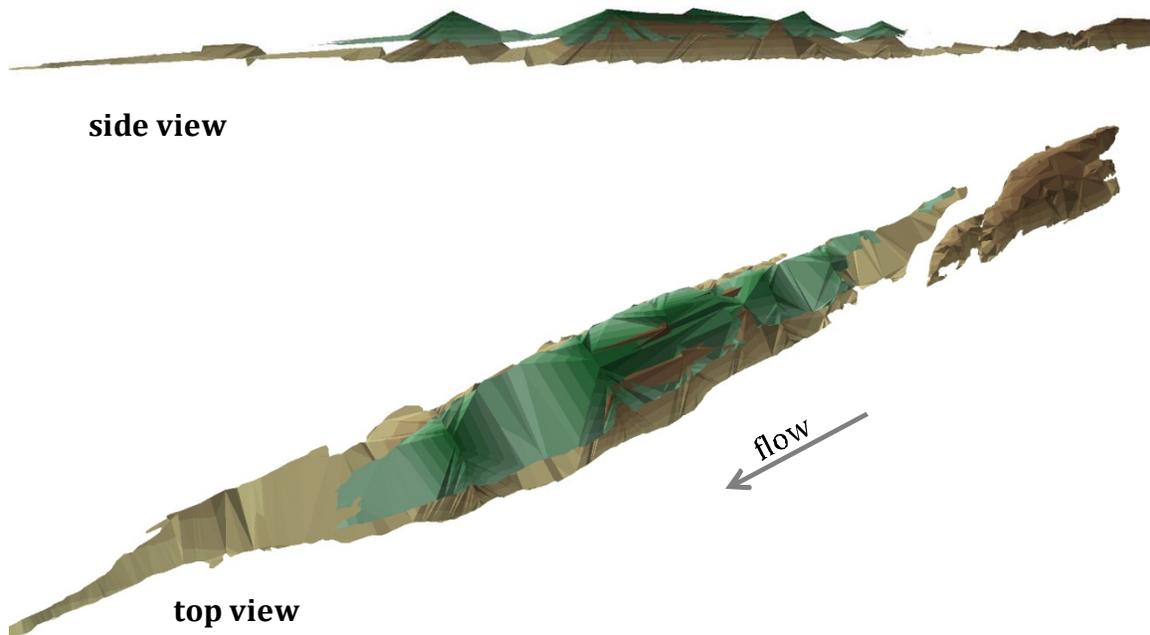
Figure 27. Overlay of March 2012 TIN (shown in green) and October 2011 TIN (shown in brown). Elevations are vertically exaggerated to show detail.

Therefore, highest rates of aggradation occurred at the bar head. Even though individual transects show evidence both aggradation and degradation, an overall net loss of material was determined to 0.33 m² when comparing all transects. It must be noted that chosen transects give an estimate of bar behavior, and that adding additional transects to the surveying technique may alter the net result. The storm event responsible for much of the change observed between transects occurred late January 2012 and the channel bar was not resurveyed until early March 2012. The period between the two surveys experienced moderate to low flow conditions during which available limited material may have been transported and deposited along the upper reaches of the channel bar. The results of transect comparison coincides with visual analysis of the survey TIN surfaces which suggests that aggradation occurs along the bar ridge of the bar with lowest elevations found in the far downstream portion of the bar (Figure 27).

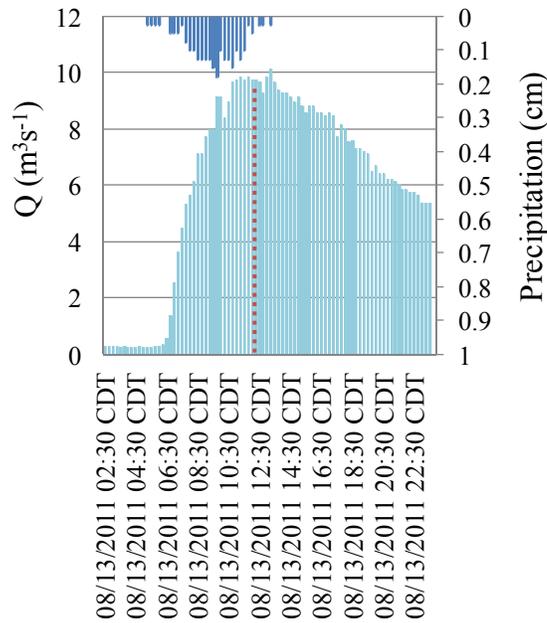
Figure 28. August 2011 hydrograph showing the relationship between discharge and precipitation. Sediment sampling time is marked by dashed line

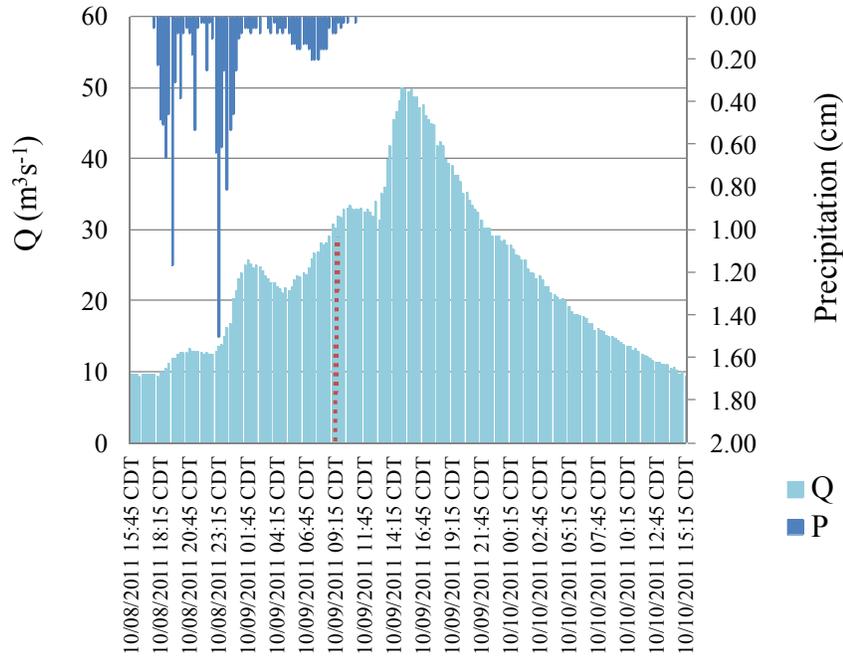
Figure 29. October 2011 hydrograph, sampling time is marked by dashed line

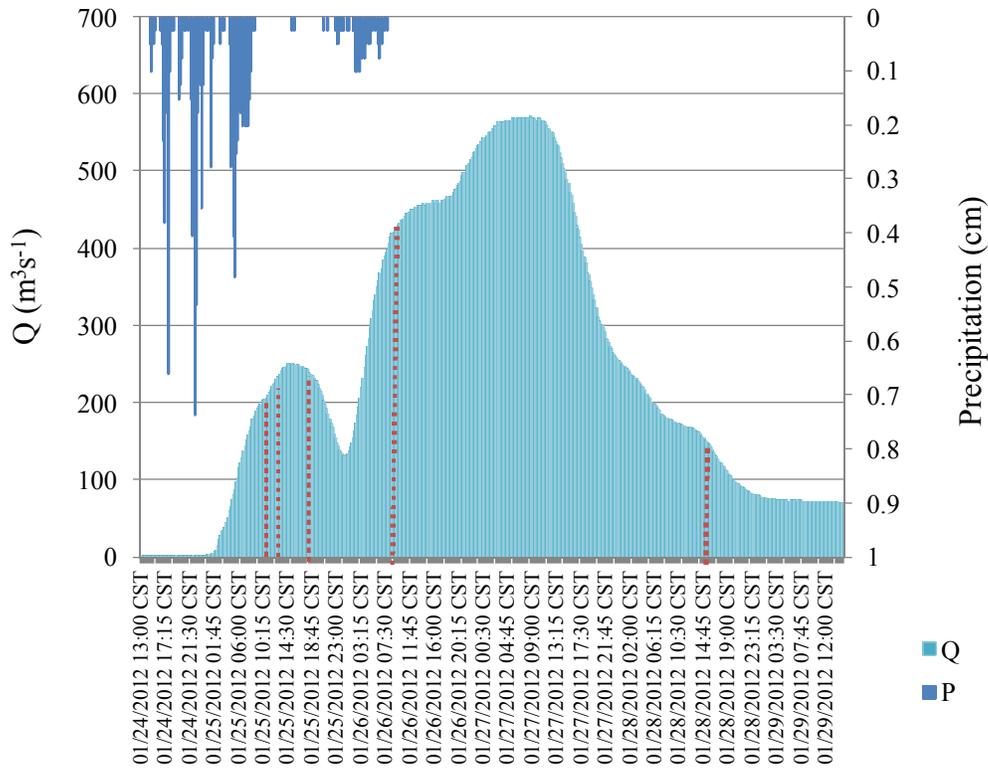
Figure 30. January 2012 hydrograph showing sediment sampling times with dashed lines

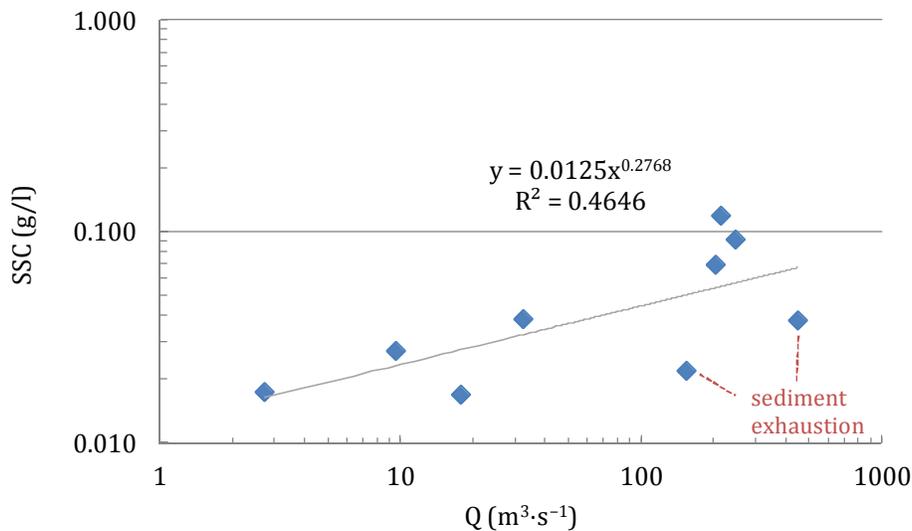
Figure 31. Correlation of suspended sediment concentration and discharge

For each of the different discharge events, five samples were taken across the bridge to capture all variability in sediment flux with depth across the channel. Highest SSC values, or mass per known volume of water, were observed along stations 3 and 4. These stations coincide with areas of shallow flow depths. The mean of each sample run was taken to establish a relationship between suspended sediment concentration and discharge. Linear regression of this relationship showed an R^2 value of 0.46. The suspended sediment-discharge relationship shown in figure 31 is impacted by two sets of samples taken during the recession limb of the January 2012 storm. This

segment of the storm event shows high discharge rates, $>240 \text{ m}^3 \cdot \text{s}^{-1}$, but relatively low suspended sediment discharge. A significant storm event will produce an increase in discharge and therefore cause an increase in turbulence. The effect of rising turbulence allows for materials to be lifted from the bed or banks of the river into suspension. Even

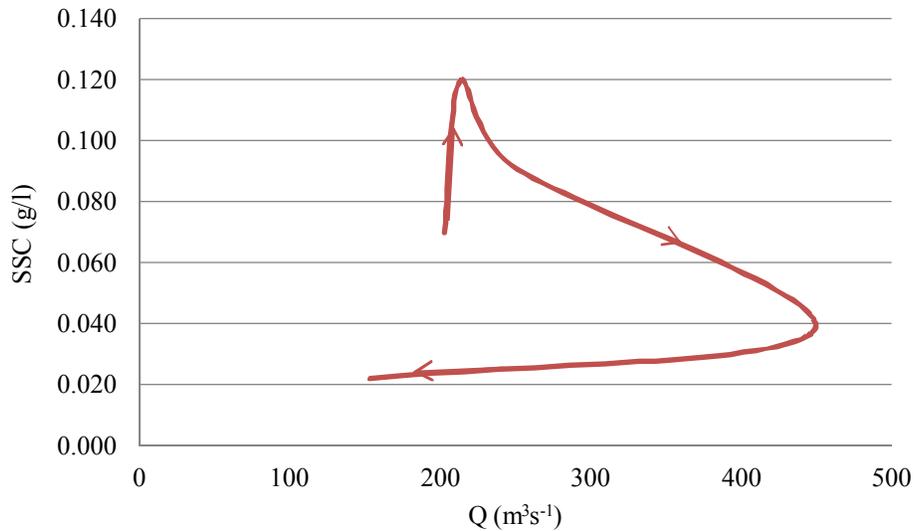
Figure 32. A hysteresis curve for the January 2012 storm event indicates that SSC peaked around $200 \text{ m}^3\text{s}^{-1}$

rising and falling limb data over a range of medium to large storm events. For the purposes of this study, only one major storm event was observed and therefore the majority of the data represents smaller magnitude events with data obtained only along the rising limb or peak of the hydrograph where SSC values are expected to be high.

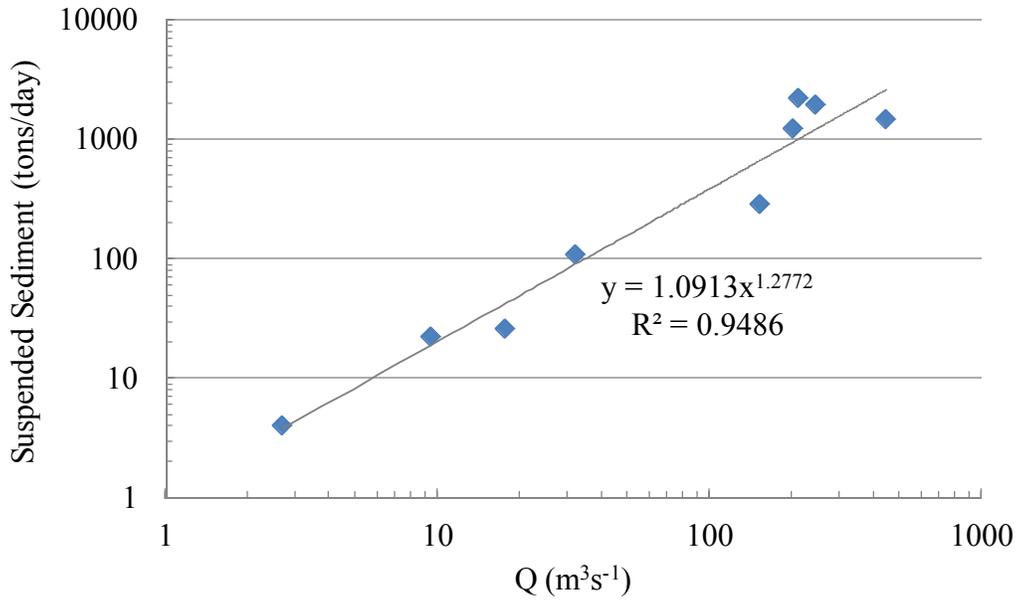
Figure 33. Relationship between suspended sediment flux and discharge

A stronger relationship exists between suspended sediment flux and discharge (Figure 33). This determines the rate of suspended sediment discharge over a specific discharge. Even though the change in suspended sediment discharge between different observed flow conditions is low, when multiplying it against the specific discharge a strong relationship is established ($R^2 = 0.95$). This determines that 95% of change in suspended sediment can be explained by a change in discharge.

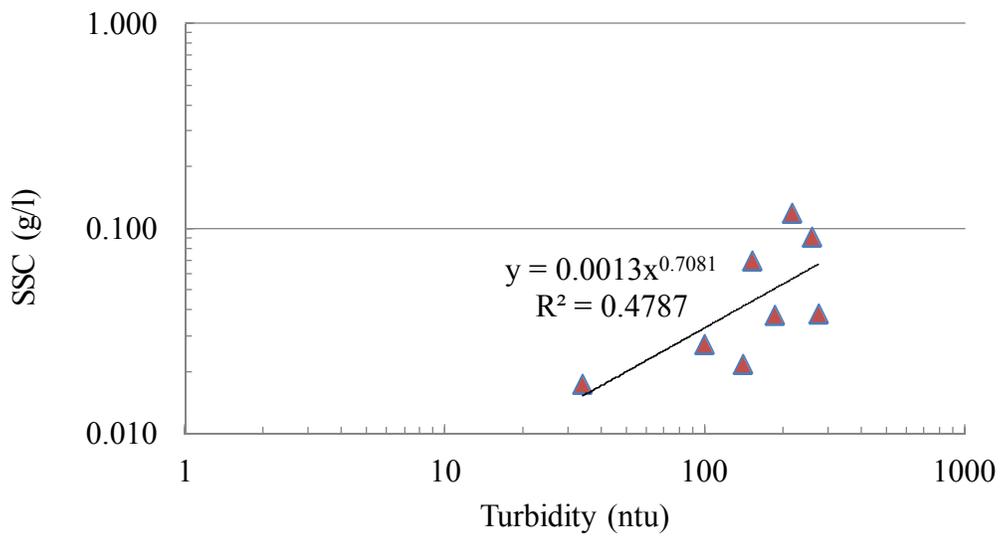
Figure 34. Relationship between turbidity measurements and physical suspended sediment samples obtained during field sampling

In an effort to build a more robust sediment rating curve, the turbidity record may aid to fill gaps of specific flow conditions that were not captured during on site sampling.

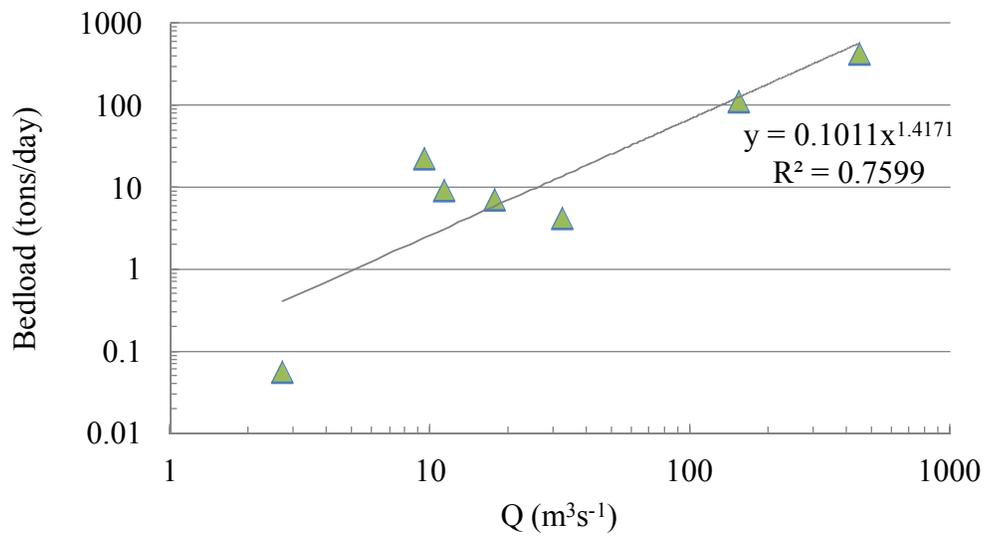
Figure 35. Bedload transportation rates according to variations in Q

bedload discharge for the different flow events determines a moderately strong relationship with an R^2 of 0.76 (Figure 35). In general, when considering the total sediment load in a river or stream, bedload tends to make up about 10% of the total. With the use of the equations established in the suspended load and bedload curves it was determined that bedload in the Brazos River near Glen Rose makes up approximately 20% of the total load.

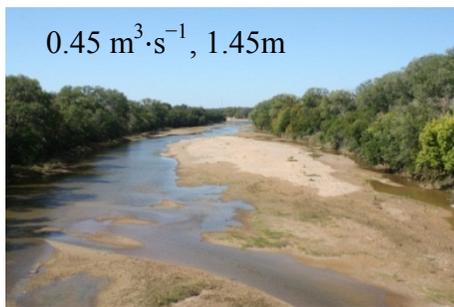
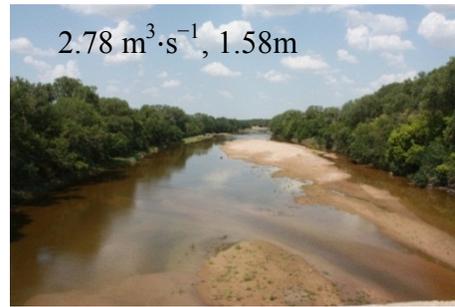
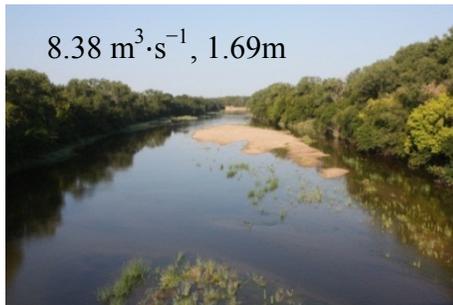
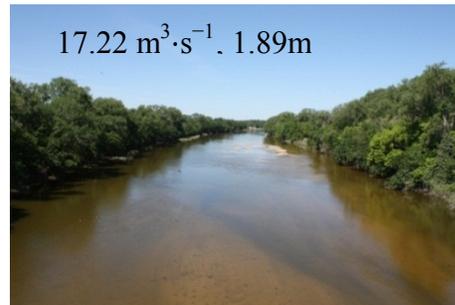
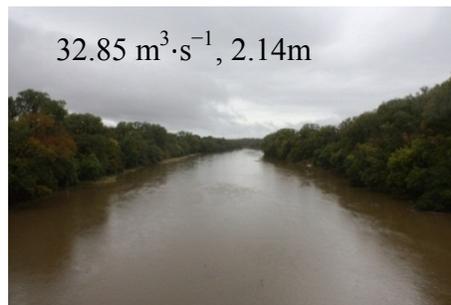
Figure 1-Appx. Photographs (2011) of bar inundation trends used to establish an inundation curve
