AN EVALUATION OF WATER AND SEDIMENT QUALITY IN A MINE-IMPACTED WATERSHED: CASE STUDY OF ELM CREEK, PICHER, OKLAHOMA

Submitted to the Graduate Faculty of the
College of Science and Engineering
Texas Christian University
In partial fulfillment of the requirements
For the degree of

Master of Science May 2024

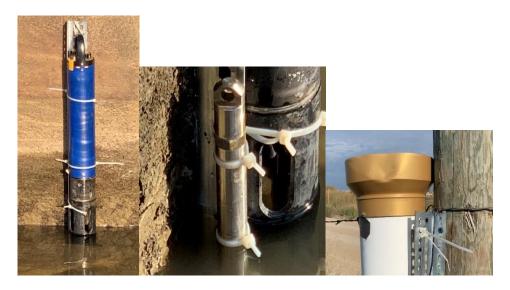
Figure 7: Continuous Monitoring Equipment. YSI EX01 Sonde (Left), Keller DCX-22 water level Data Logger (Middle), and RG 600 Tipping Bucket Rain Gauge (Right)

YSI EX01 multiparameter Sondes and Keller DCX-22 water level data loggers were installed at the sample sites (see figure 7) to measure turbidity and water depth, respectively. The Sondes were calibrated according to the manufacturer's guidelines for turbidity (Finegan, 2018). The water data loggers measured water depth in inches and were calibrated by measuring atmospheric pressure in a depth of 0 inches of water to 12 inches of water in the laboratory. Because the Keller DCX-22 water level loggers proved unreliable, and because flow depth was *the* critical hydrologic parameter needed to compute discharge, a second water level system was installed at Distal West. This comprised a YSI WL16 data logger and submersible pressure transducer combination.

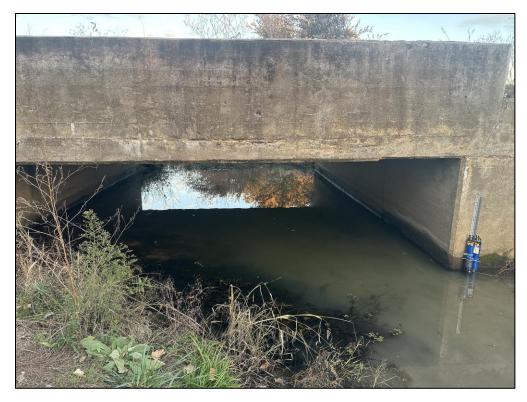
Figure 13: Deep Pool, low energy slope, at Distal West site.

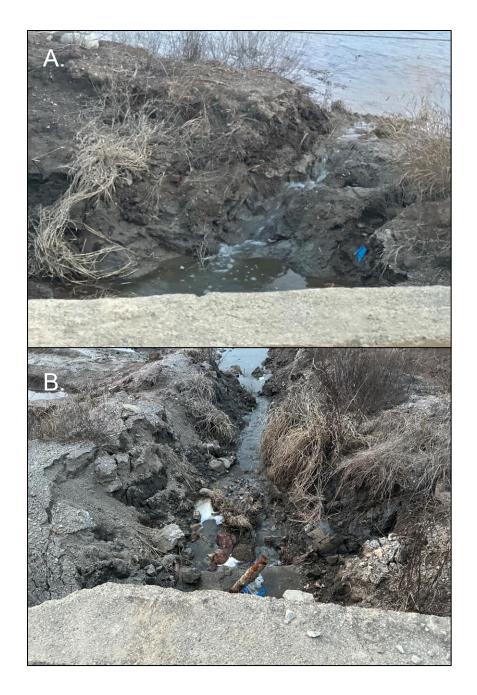
Figure 17: Downcutting of the stream channel upstream (A.) and downstream (B.) of the Bird Dog South Culvert.

For example, Fe samples ranged between 0 and 22400 mg/kg, while Cd ranged between 24.4 and 423 mg/kg. Bird Dog South is obviously a highly disturbed site (see Figure 12) with sediments being excavated and reworked during both the removal of the chat pile and the construction of the retention basins upstream and downstream of the culvert. There is simply no way to know the likely residence time of the sediments within the culvert at Bird Dog South or whether the material we sampled is redeposited particles from the chat pile itself or freshly exposed sediment that was never actually contaminated due to downcutting through the culvert (see Figure 17).
