DOES A TEXTURED COATING ALTER BAT ACTIVITY AND BEHAVIOR
IN PROXIMITY TO WIND TURBINE TOWERS?

BRYNN HUZZEN

Submitted to the Graduate Faculty of
the College of Science and Engineering
Texas Christian University
in partial fulfillment of the requirements
for the degree of

May 2019

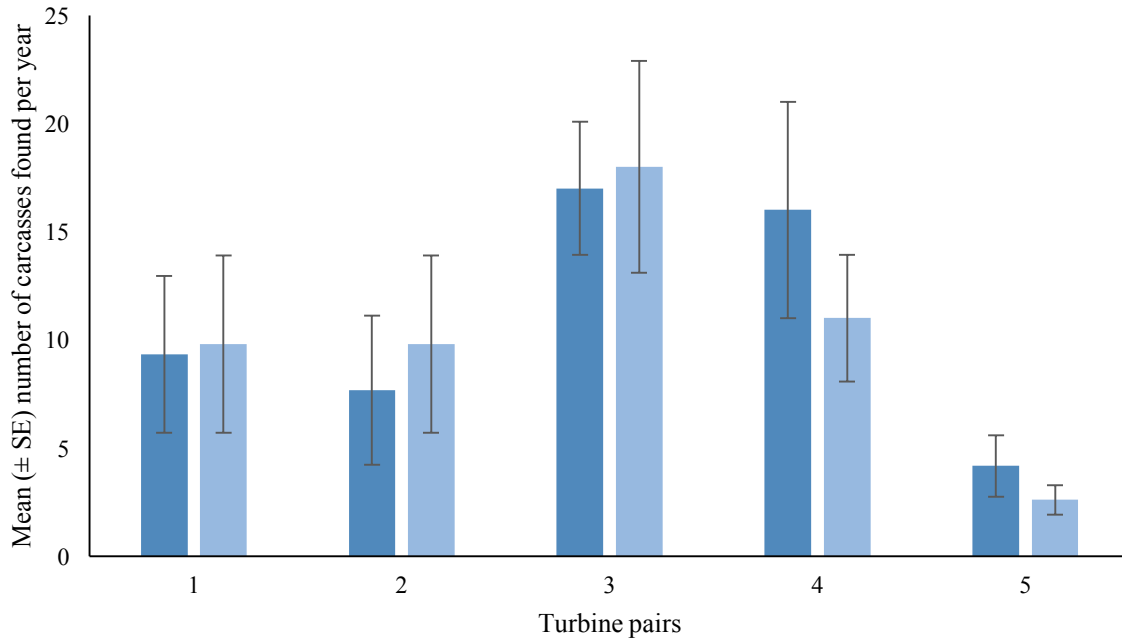
Figure 2: Average (\pm SE) number of bat carcasses found per year at turbine pairs 1-5, shown in Fig. 1, during fatality searches at Wolf Ridge from 2009 to 2014. The shades of blue indicate the 2 turbines within each pair.

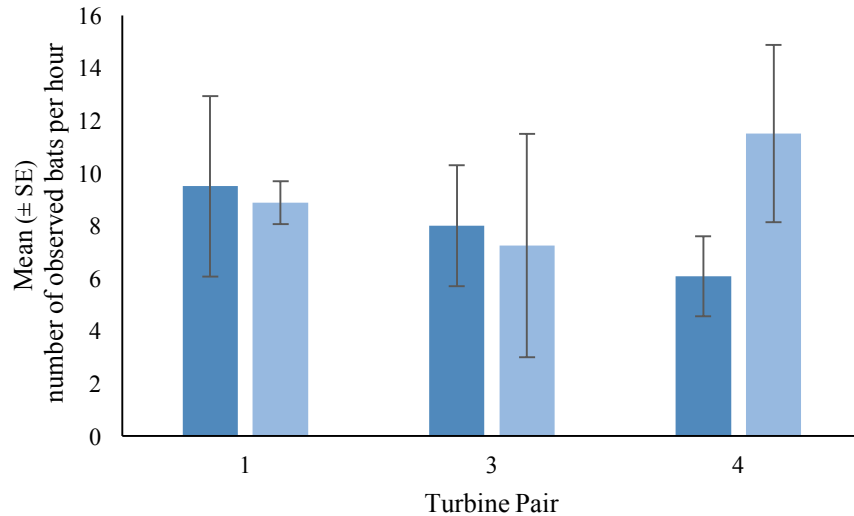
Figure 3: The mean number (\pm SE) of observed bats per hour recorded at each turbine pair studied at Wolf Ridge from 9 July to 10 August 2016 during the feasibility study. The shades of blue indicate the 2 turbines within each pair. Turbine Pair 1 was surveyed for 5 nights, Turbine Pair 3 for 4 nights, and Turbine Pair 4 for 7 nights.

The results of the behavioral surveys, shown in Fig 3, demonstrated that observed levels of activity were comparable between each of the selected pairs. To confirm this, we used a series of paired t tests and found no significant difference in the number of bats observed per hour between turbines in each pair (Pair 1: $t=0.17$, $df=3$, $P=0.876$; Pair 3: $t=3$, $df=1$, $P=0.205$; Pair 4: $t=-1.77$, $df=4$, $P=0.151$).

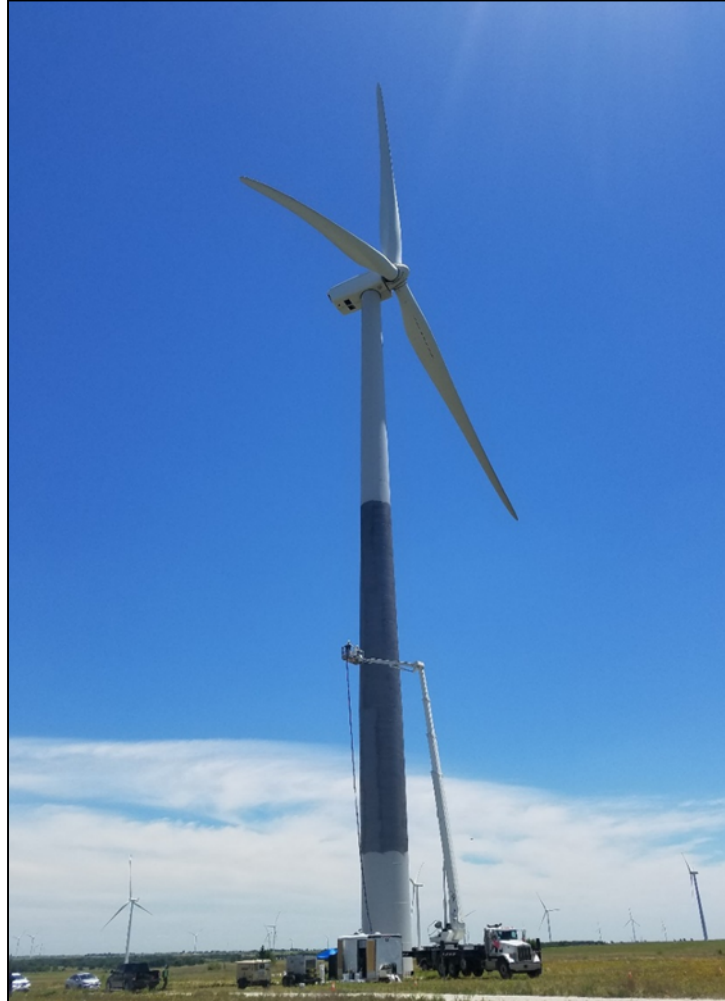
Figure 7: Texture coating application at a wind turbine at Wolf Ridge in June 2017.

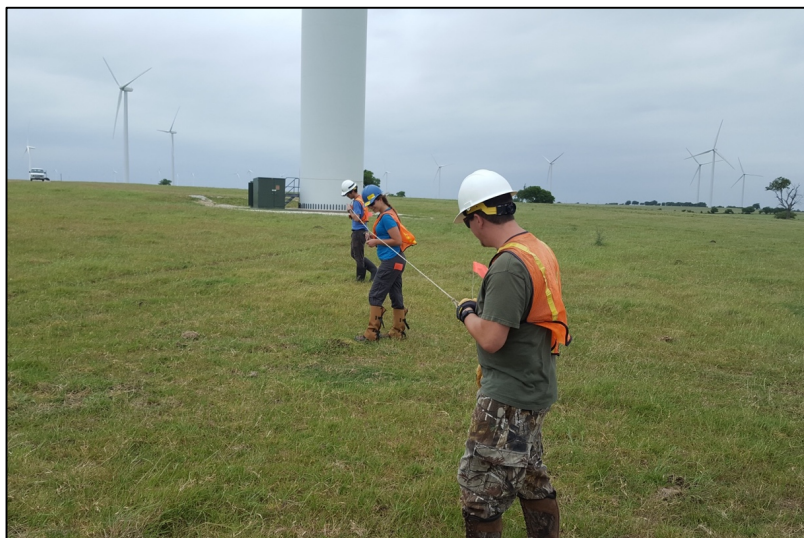
Figure 11: Field technicians searching for bat carcasses in the 45 m radius area around a wind turbine at Wolf Ridge.

In teams of 2-3, we searched for bat carcasses on the gravel, pad, and surrounding area at each turbine. Gravel searches were initiated 80 m from the tower using a laser range finder, and we then investigated the area around the tower using the rope method, (as described in Baerwald *et al.* 2009). For this, we attached a rope around the turbine tower approximately 2.5 m above ground level, from which we attached a second rope that extended 45 m from the tower. This second rope was attached at specified cardinal directions (i.e., between N and E, between E and S, etc.; hereafter referred to as the starting angle). Surveyors were spaced at approximately 4.5 m intervals along the rope, and we slowly walked around the turbine holding the rope taut while methodically scanning the ground for carcasses (Fig. 11). This technique created a spiral search path centered around the base of the turbine (Fig. 12). The starting angle and direction (clockwise or counter-clockwise) were rotated each search day to minimize the occurrence of potential “blind spots” within each search plot.

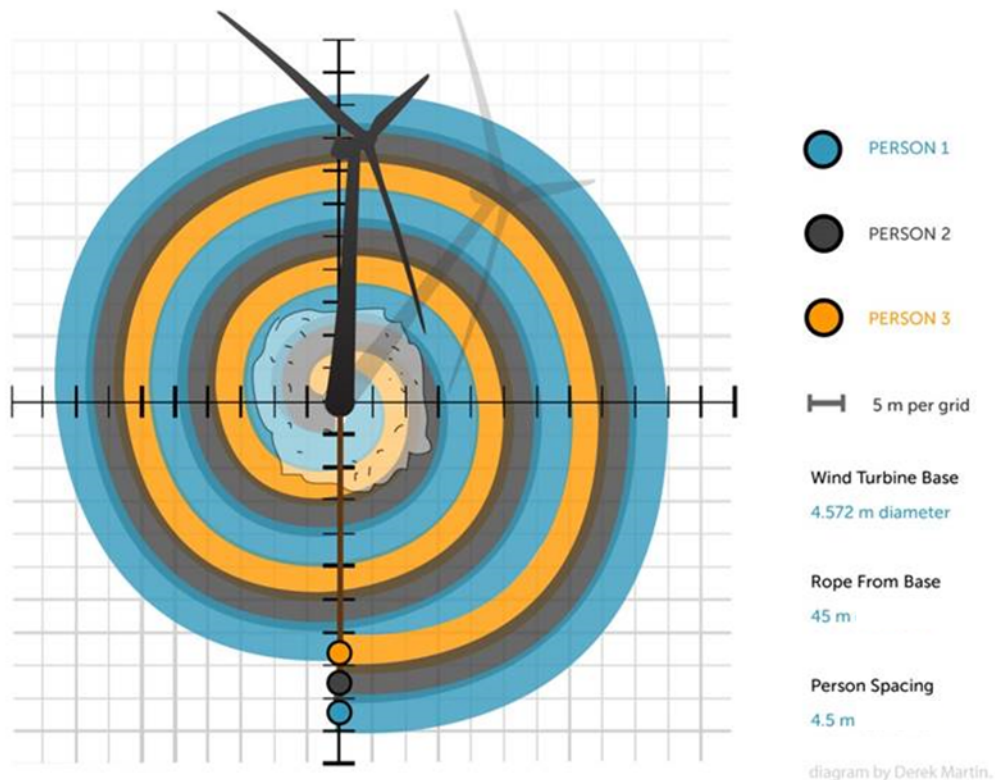
Figure 12: Spiral search pattern implemented for fatality monitoring surveys at Wolf Ridge.

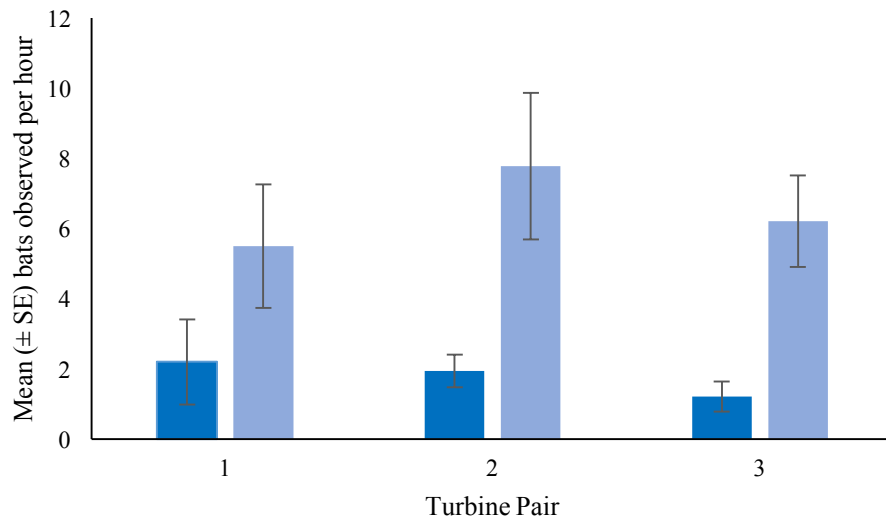
Figure 15: The mean (\pm SE) number of bats observed per hour during the pre-texture application stage over 16 survey nights from 20 May to 18 June 2017. The shades of blue indicate the 2 turbines within a pair.

Next, we compared bat activity between all turbines during the pre- and post-texture application stages. Across the 3 pairs of turbines surveyed during the pre-texture stage, the mean number of bats observed per hour ranged from 2.2 to 7.9 over 16 survey nights (Fig. 15).

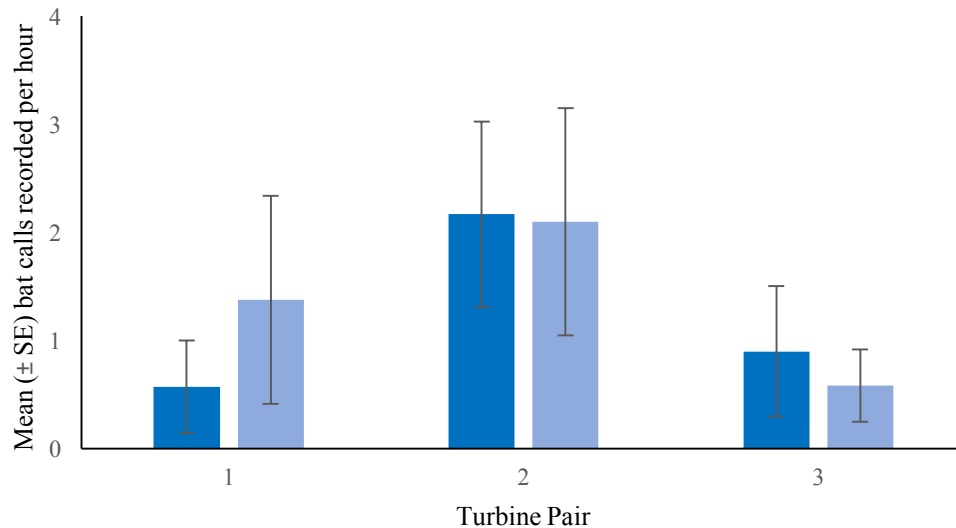
Figure 17: The mean (\pm SE) number of bat calls recorded per hour during the pre-texture application stage over 16 survey nights from 20 May to 18 June 2017. The shades of blue indicate the two turbines within a pair.

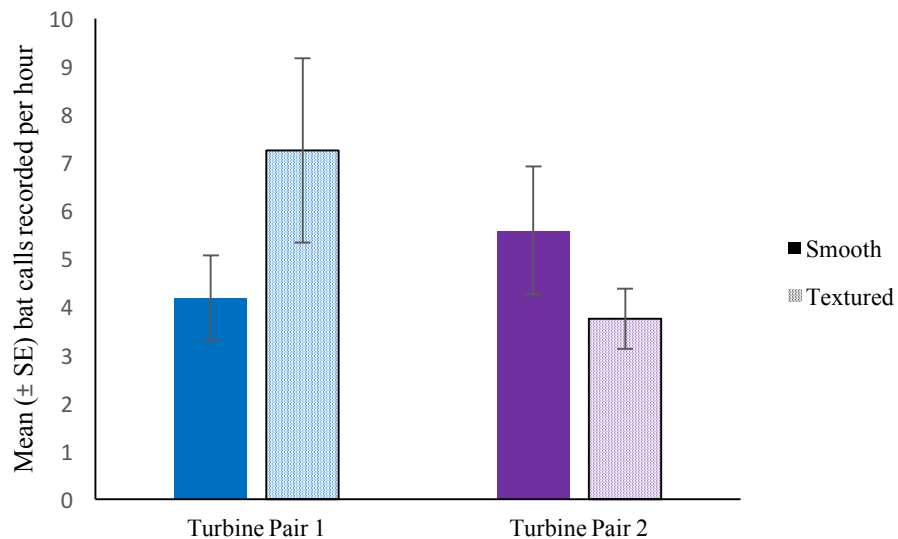
Figure 18: The mean (\pm SE) number of bat calls recorded per hour at the smooth (solid bars) and textured (patterned bars) turbines over 27 survey nights for each pair from 24 June to 22 September 2017. Blue represents Turbine Pair 1, while purple represent Turbine Pair 2.

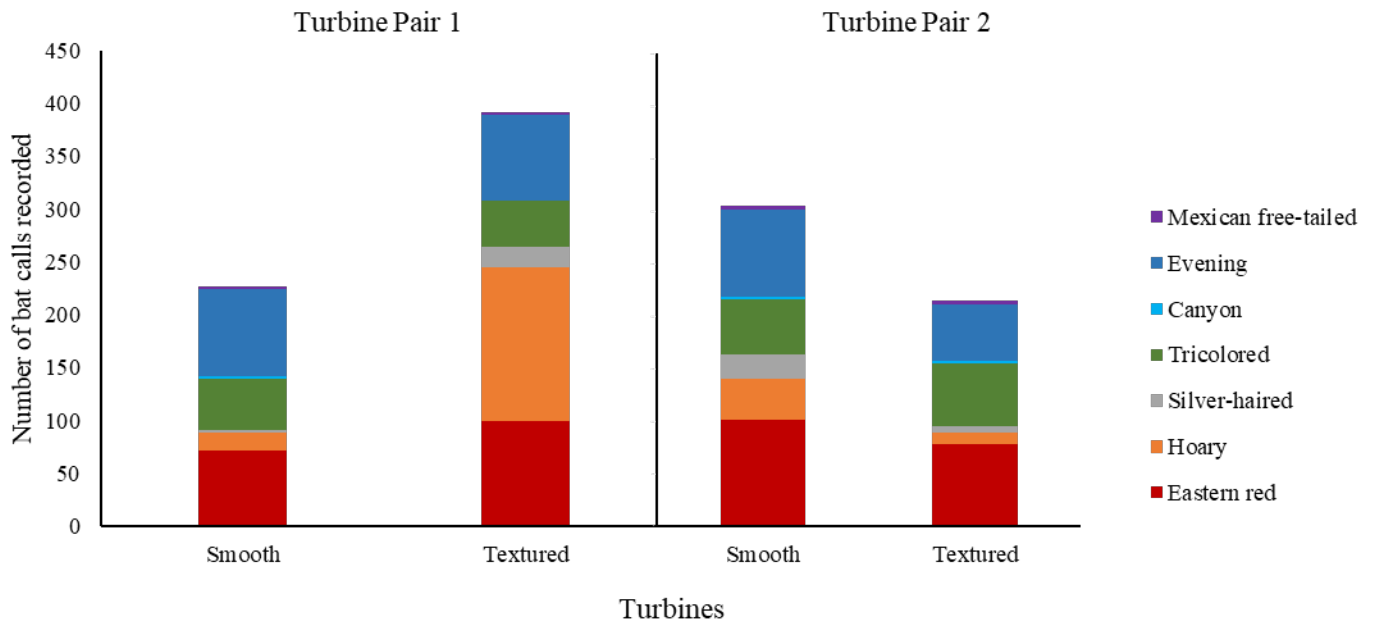
Figure 19: The number of acoustic calls recorded per hour for each bat species at Wolf Ridge wind turbine towers during the post-texture application stage. Each turbine pair was surveyed 27 nights from 24 June to 22 September 2017.

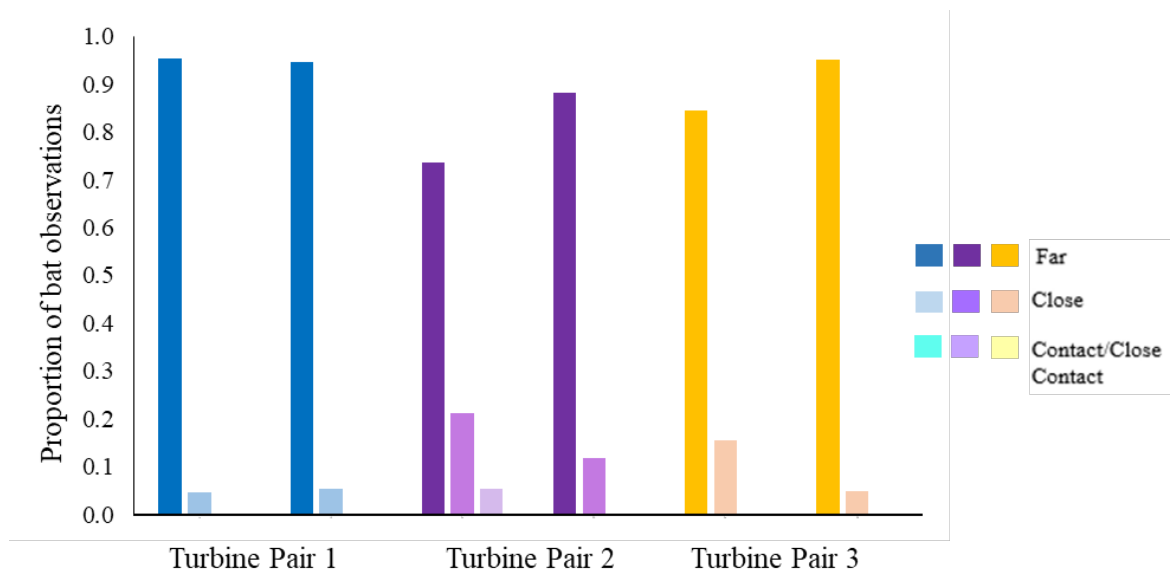
Figure 20: The proportion of bats observed in each distance category at each turbine studied over 5-6 survey nights during the pre-texture application stage from 20 May to 22 September 2017. Turbine Pair 1 is shown in blue, Turbine Pair 2 is in purple, and Turbine Pair 3 is in yellow.

To determine if proximal bat activity differed between smooth and textured turbines, we first confirmed that such distance-related activity was consistent between turbines in each pair during the pre-texture application stage. Note that as we observed <10 bats categorized as ‘contact/close contact’ across our entire survey period (see Appendix B), we proceeded to combine ‘contact/close contact’ observations with ‘close’ observations for the following analyses (hereafter referred to as ‘all close’). The proportion of bat passes categorized as ‘all close’ ranged from 0.04 to 0.26 per turbine (Fig. 20).

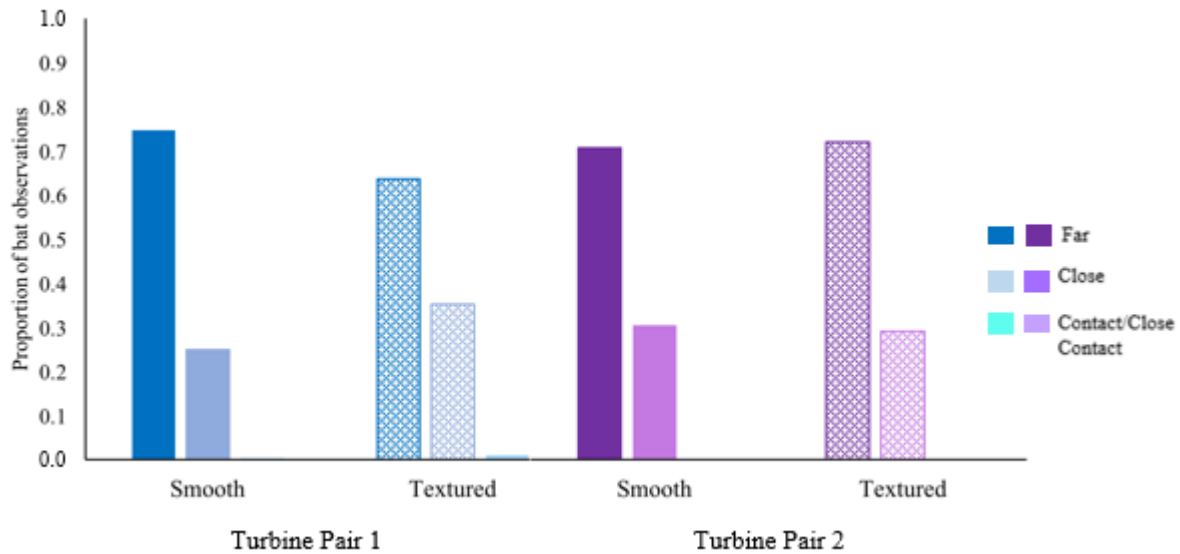
Figure 21: The proportion of observations in each distance category at each turbine studied over 27 survey nights during the post-texture application stage from 24 June to 22 September 2017. Turbine Pair 1 is shown in blue, while Turbine Pair 2 is shown in purple. The patterned bars indicate the textured turbine in each pair.

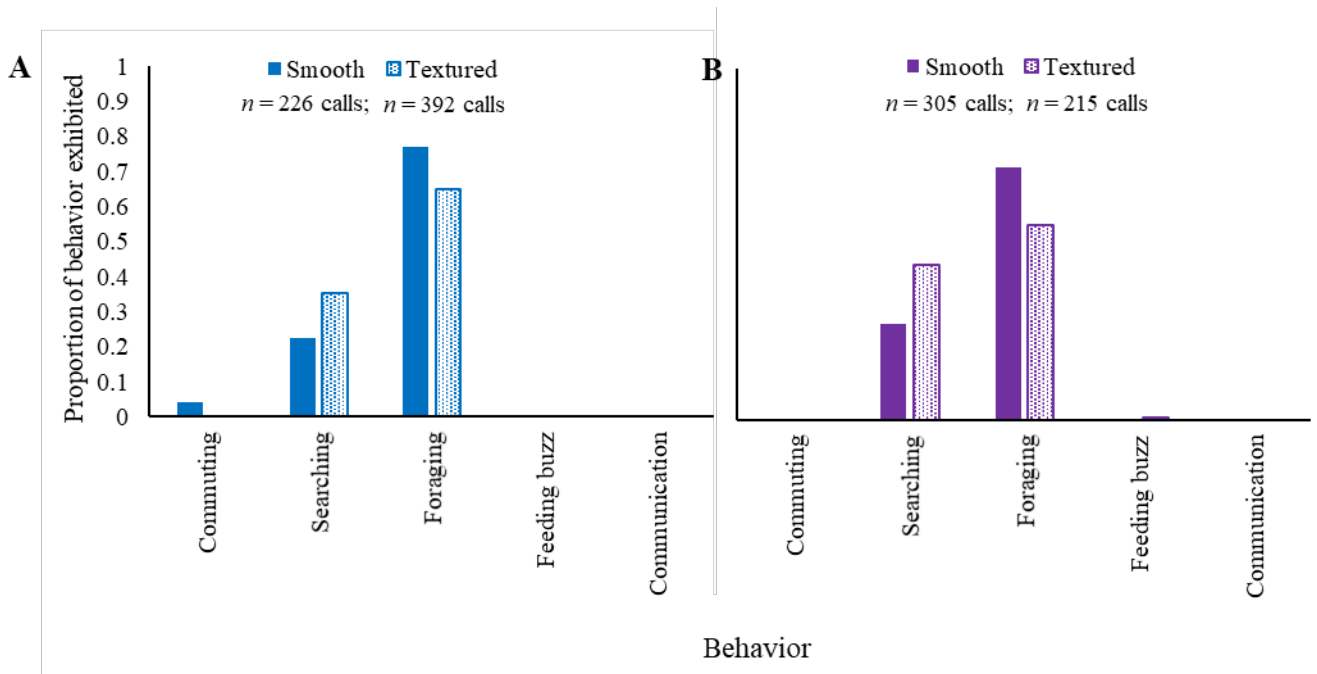
Figure 24: The proportion of bats exhibiting each behavior identified by acoustic calls at turbine pairs surveyed at Wolf Ridge over 27 survey nights at each turbine pair from 24 June to 22 September 2017. **A** delineates Turbine Pair 1, shown in blue, while **B** represents Turbine Pair 2, shown in purple.

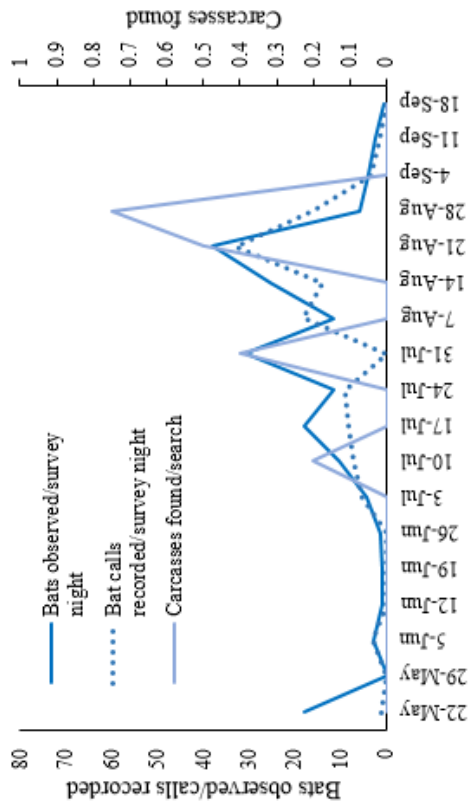
Figure 27: The pattern of bat fatality (measured by number of bat carcasses found per search) and bat activity (in both observed and acoustic calls recorded per survey night) across the entire survey period at Wolf Ridge for each surveyed turbine. Turbine Pair 1 is shown in blue and Turbine Pair 2 is shown in purple. The shading indicates when the texture coating was applied to the 2 textured turbines.

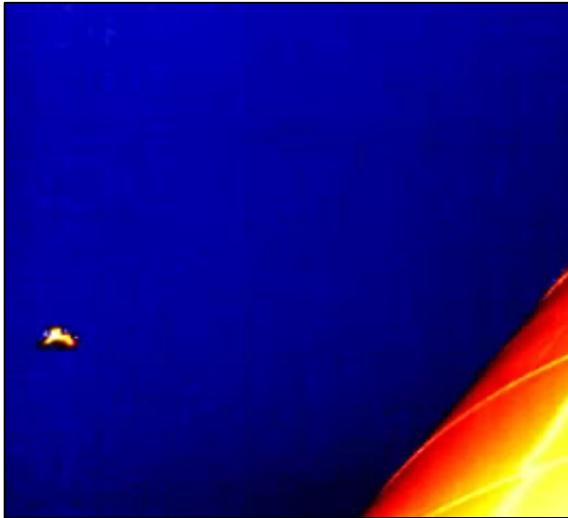
Image 2a: This object was determined to be a bird because it has a distinct body and wings as well as a distinct tail.

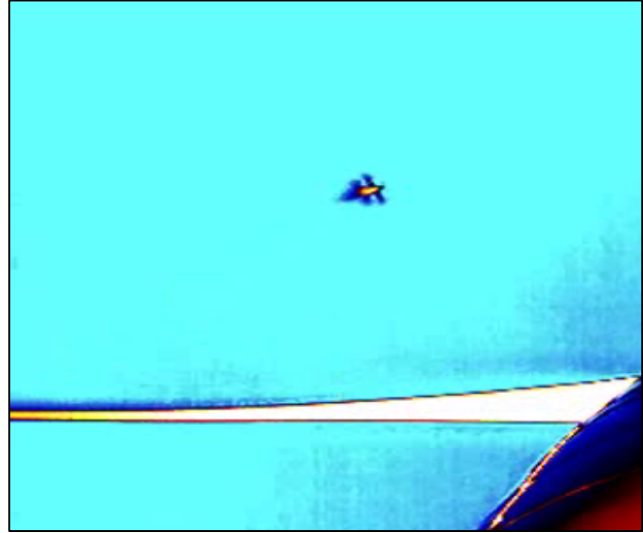
Image 2f: This object was determined to be a dragonfly because it has 2 pairs of wings.

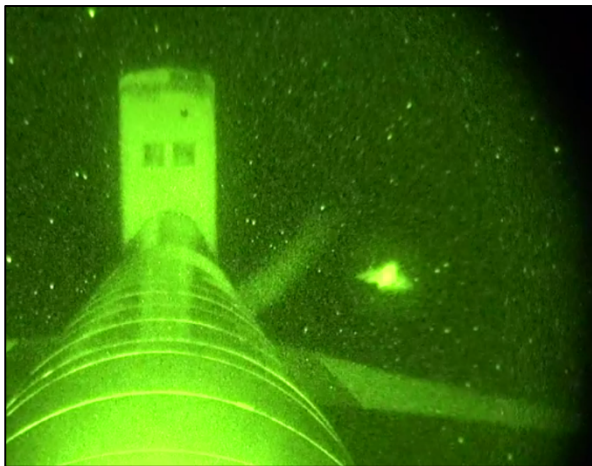
Image 4a: This object was determined to be a bat because it has a distinct head, body, and wings. The joints of the wing are visible in this image.

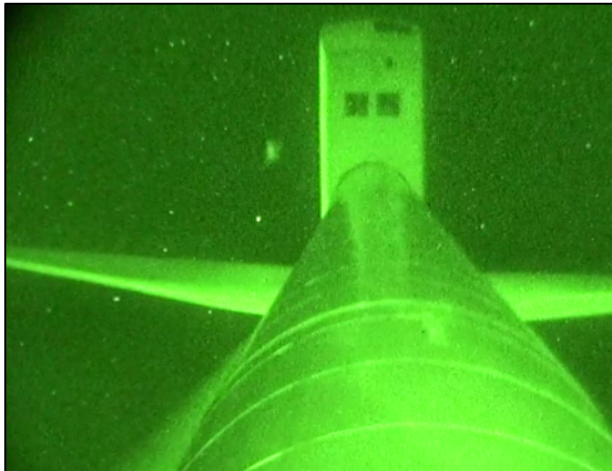
Image 4e: This object was determined to be a bat because it has a distinct body and wings.

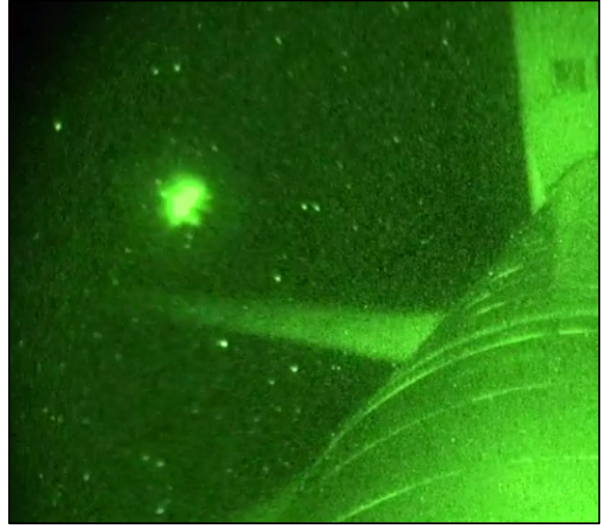
Image 5e: This object was determined to be an insect such as a dragonfly because it has 2 pairs of wings.

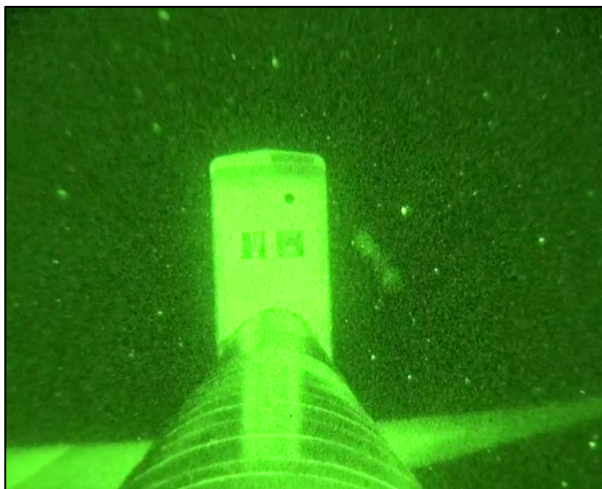
Image 5f: This object was determined to be an insect such as a grasshopper or beetle because it is seen as a series of dots in a line with a straight flight path. This organism is reflecting less light than the objects in Image 5a and 5b.

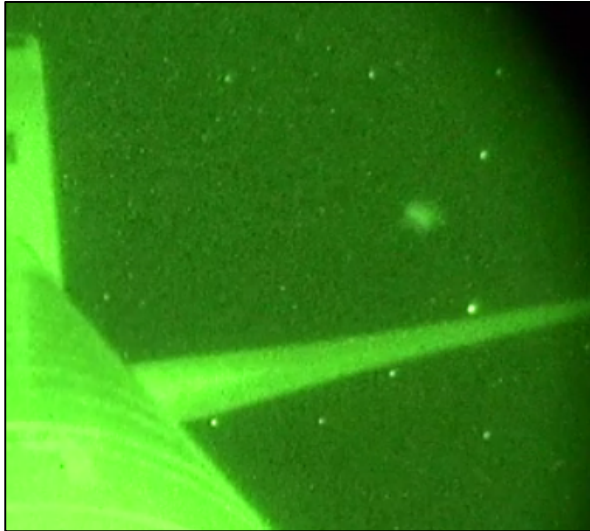
Image 6a: This object was classified to be a possible bat because it does not have distinct wings or any characteristic that suggests it is a bat or a non-bat. Note the object appears out of focus.

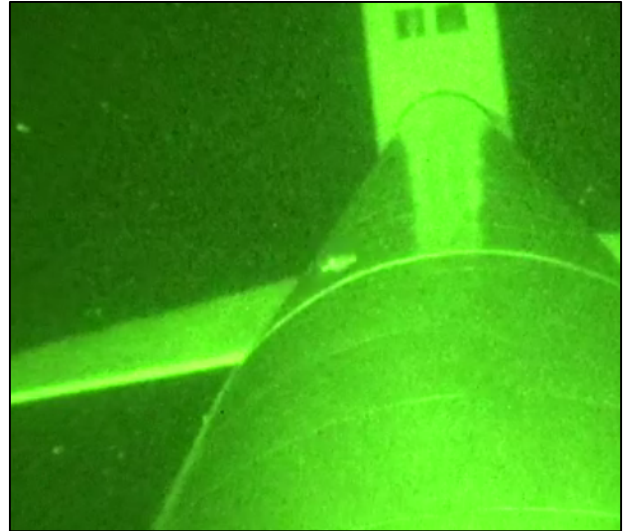
Image 6b: This object was classified to be a possible bat because it does not have distinct wings or any other defining characteristic of a bat or non-bat.

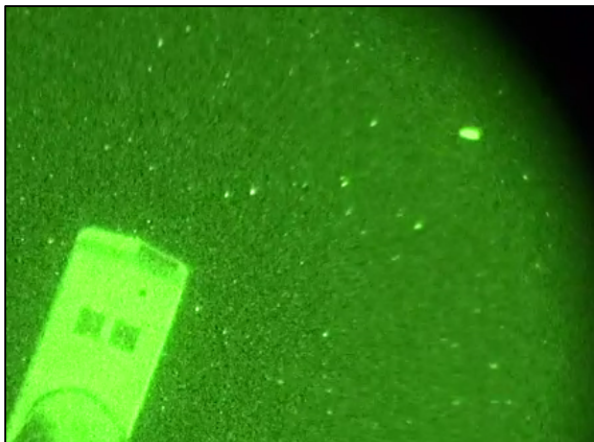
Image 6c: This was classified to be a possible bat because it does not have distinct wings or any other defining characteristic of a bat or non-bat.
